VITA YZ[®] SOLUTIONS

Technical and scientific documentation

Date of issue: 2022-03

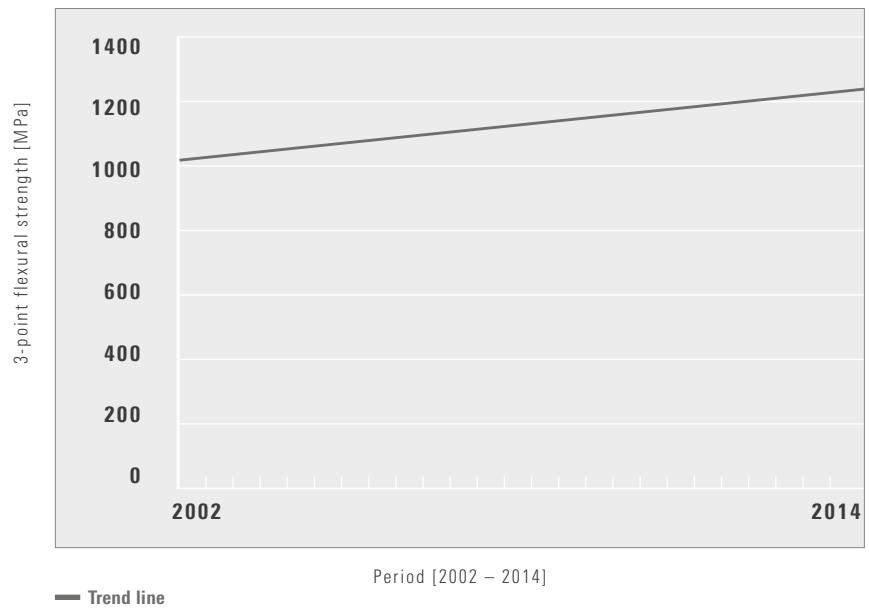
3-point flexural strength of VITA YZ T within the scope of internal batch testing

Figure 1: Flexural strength values from 2002 to 2014; determined within the scope of internal quality tests, source: Internal study, VITA R&D, (Gödiker, 09/2014, [1] cf. p. 34)

One example is the improvement of mechanical properties of VITA YZ T, such as the 3-point flexural strength (cf. Fig. 1). This documentation provides an overview of the most important technical and scientific data of VITA YZ SOLUTIONS.

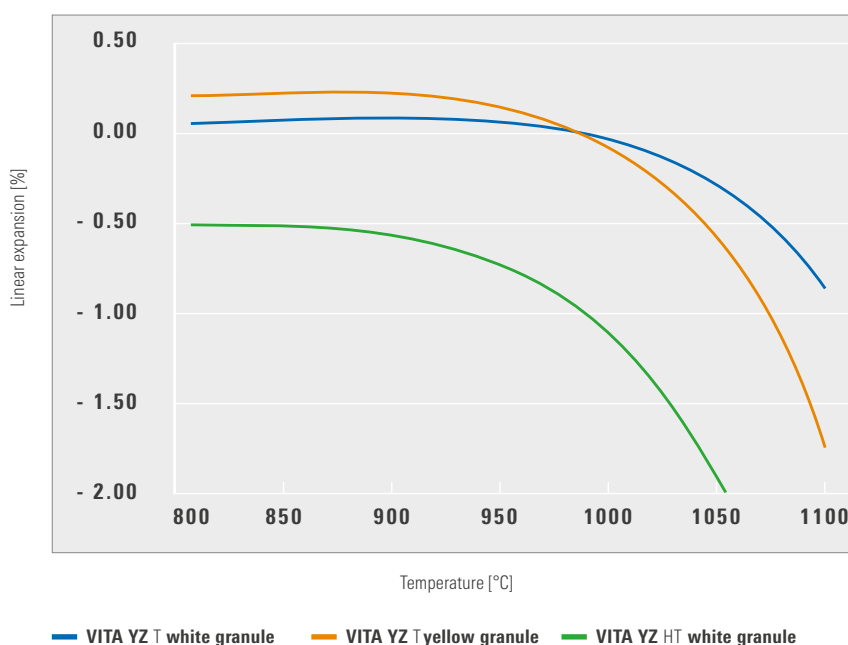
Dilatometer measurements of various zirconia granules in the range of the presintering temperature

Figure 2: Study of the sintering behavior of various VITA YZ granules
 Source: Internal study, VITA R&D (Gödiker, 11/2014 [1] cf. p. 34)

VITA focuses on modern procedures and measuring techniques (cf. Fig. 2) to be able to determine the differences in a precise manner. The granules are optimized in an industrial process (e.g. by material-specific presintering) so that the various types do not differ in their machinability and sintering properties, when they are used in practices and laboratories.

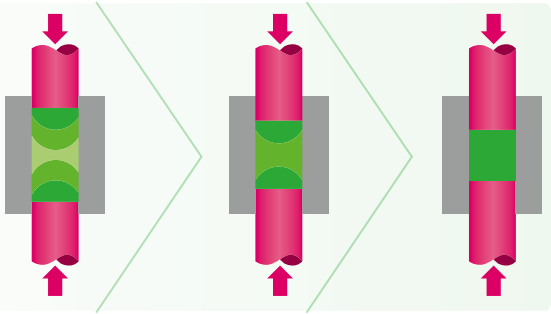
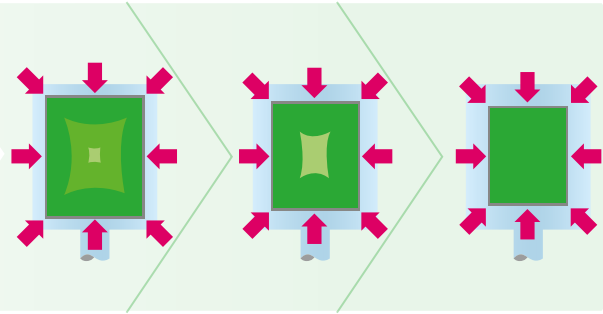
Step 1: Pressing process, uniaxial, two-sided

Step 2: Pressing process, isostatic

Figure 3: Schematic view of the pressing process for VITA YZ SOLUTIONS blanks

First, the basic shape of the zirconia blanks of VITA Zahnfabrik is achieved in a uniaxial pressing process and then the blanks are repressed isostatically in a high pressure container. The homogeneous density that is achieved is an essential precondition for homogeneous sintering behavior. The presintering process – that is, the industrial firing process – is precisely adjusted to the respective batch and blank geometry.

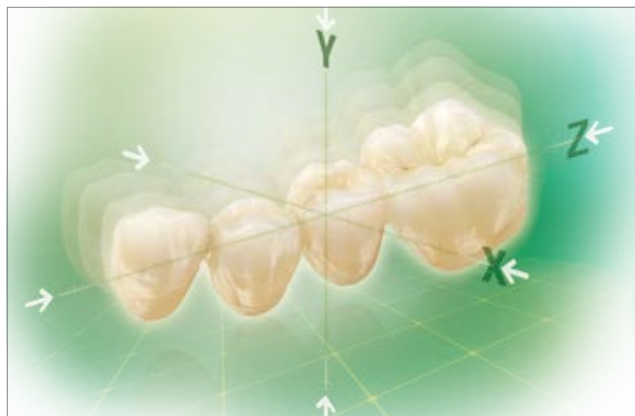
Figure 4: Example of sintering shrinkage (X-,Y-,Z-dimension)

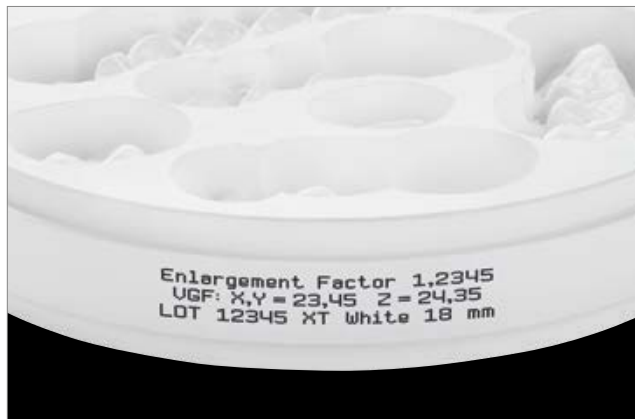
Figure 5: Example of enlargement factors indicated on blanks

Another essential step in accessing accurate sintering results is the precise determination of the enlargement factor. VITA Zahnfabrik determines this factor in all three spatial dimensions (X-, Y-, Z-dimension) for each production batch and integrates the information in the print on the blank (as a bar code or plain text). Some manufacturers, however, only indicate average values. Exact determination of sintering shrinkage and the precision of fit of the densely sintered dental object is particularly essential for multi-unit bridge constructions.

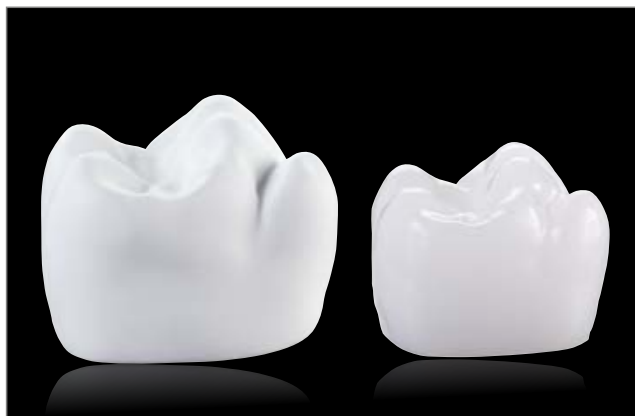
Figure 6: Example of sintering shrinkage of zirconia by approx. 20 %

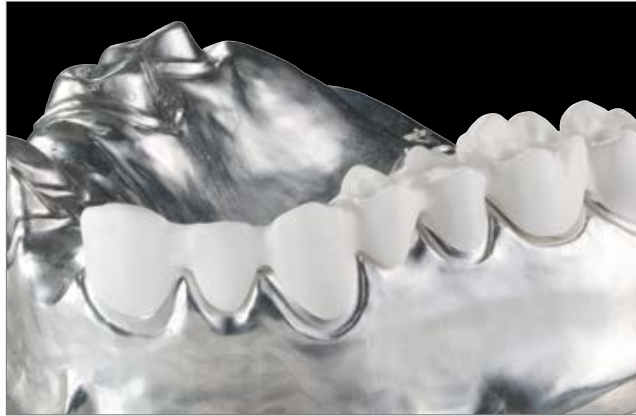
Figure7: Example of test fit with model made of metal

The final quality inspection at VITA is carried out using a pass or fail of the test fit. For this purpose, a bridge structure with a maximum size indicated for the respective material is fabricated (CAD/CAM fabrication) using the enlargement factor determined for each batch; the structure is densely sintered and the fit is checked (cf. 2.8) on a standardized steel model (cf. Fig. 7).

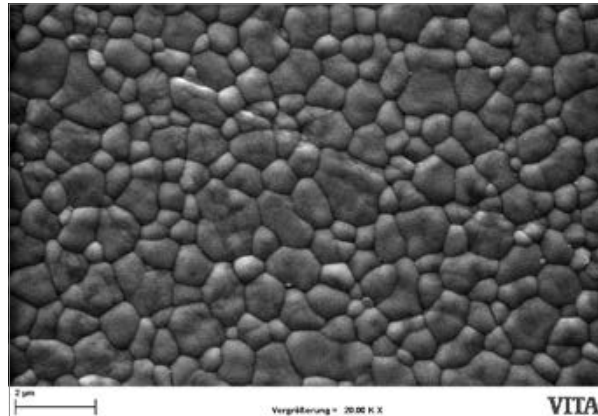
Figure 8: VITA YZ T at 20,000x magnification

Based on particularly high quality standards, VITA YZ features a homogeneous microstructure without pores or defects (cf. Fig. 8). The sintered microstructure features an average particle size of approx. 500 nm. Contamination and structural defects can sometimes be found (cf. Fig. 9) in low-quality zirconia blanks (often low price products). Some defects, however, can only be detected at high magnification. Depending on the size and position in the structure, the defects may deteriorate the mechanical properties.

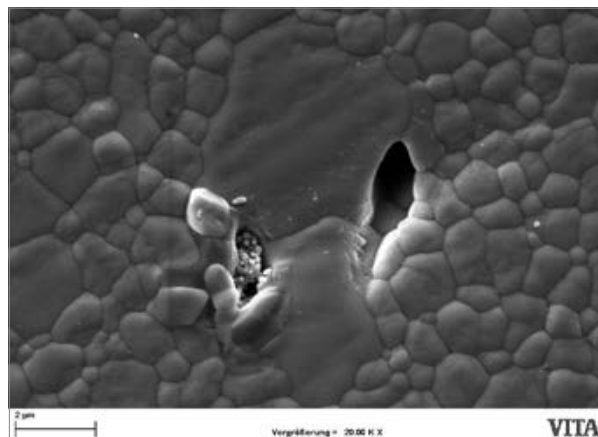
Figure 9: Competitor's zirconia at 20,000x magnification

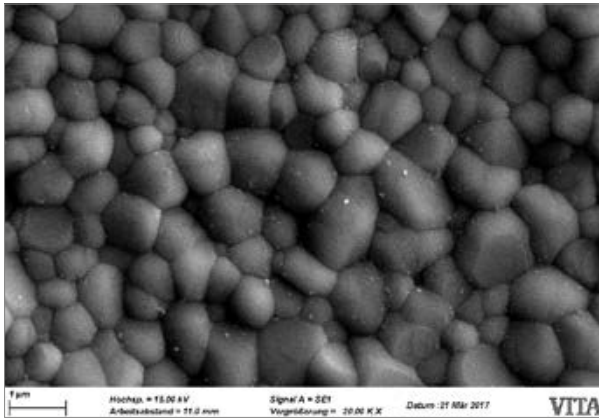
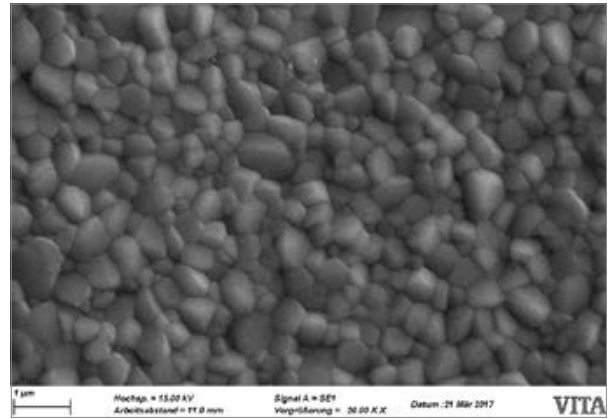
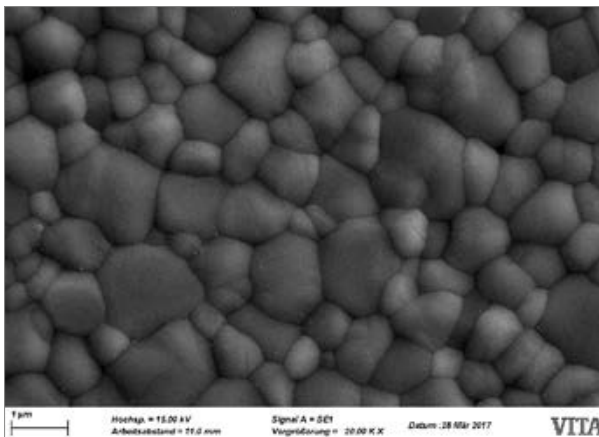
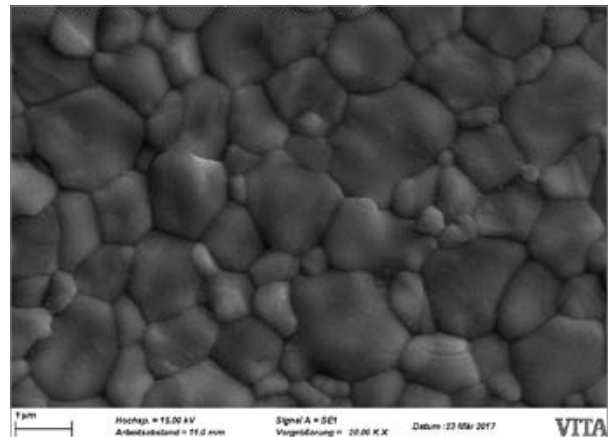
Figure 10: VITA YZ T at 20,000x magnification

Figure 11: VITA YZ HT at 20,000x magnification

Figure 12: VITA YZ ST at 20,000x magnification

Figure 13: VITA YZ XT at 20,000x magnification

The particle sizes (and with them the proportion of particle boundaries) have a direct influence on the light refraction, and as a result, the translucency of the different materials. The larger the particles, the smaller the number of boundaries where the light is refracted. The comparatively translucent appearance of materials, such as VITA YZ T (particle size ~ 1.0 µm), can be attributed to that. The chemical composition, in particular the yttrium oxide content and aluminium oxide (Al₂O₃) enrichment at the grain boundaries, influence the light refraction properties.

VITA YZ T, with a wt% of approx. 0.25, has a considerably higher Al₂O₃ proportion than the other three VITA YZ types and features a particle size of approx. 0.5 µm. Consequently, this type appears comparatively opaque.

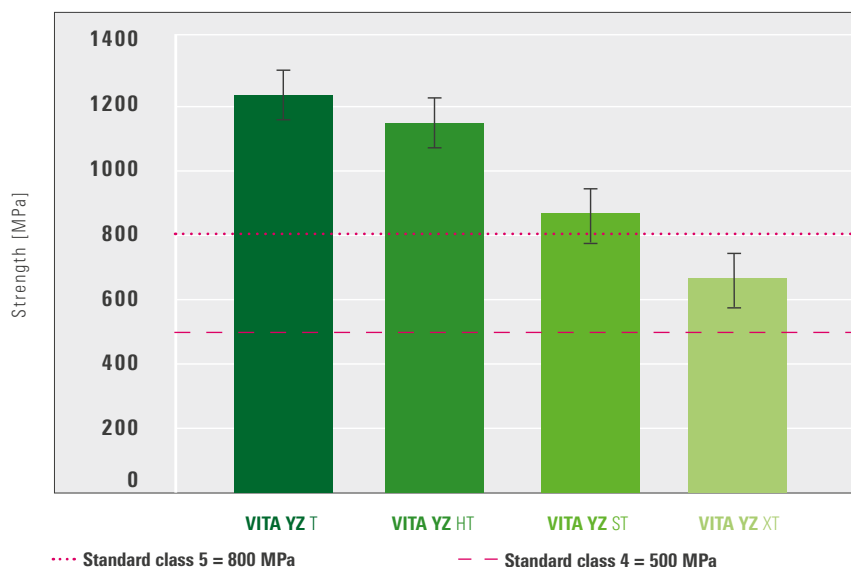
3-point flexural strength of the different VITA YZ types

Standard class 4¹⁾: ≥ 500 MPa
monolithic crowns or crown substructures
monolithic bridges or bridge substructures with three units or less
Standard class 5¹⁾: ≥ 800 MPa
monolithic bridges or bridge substructures with four units or more

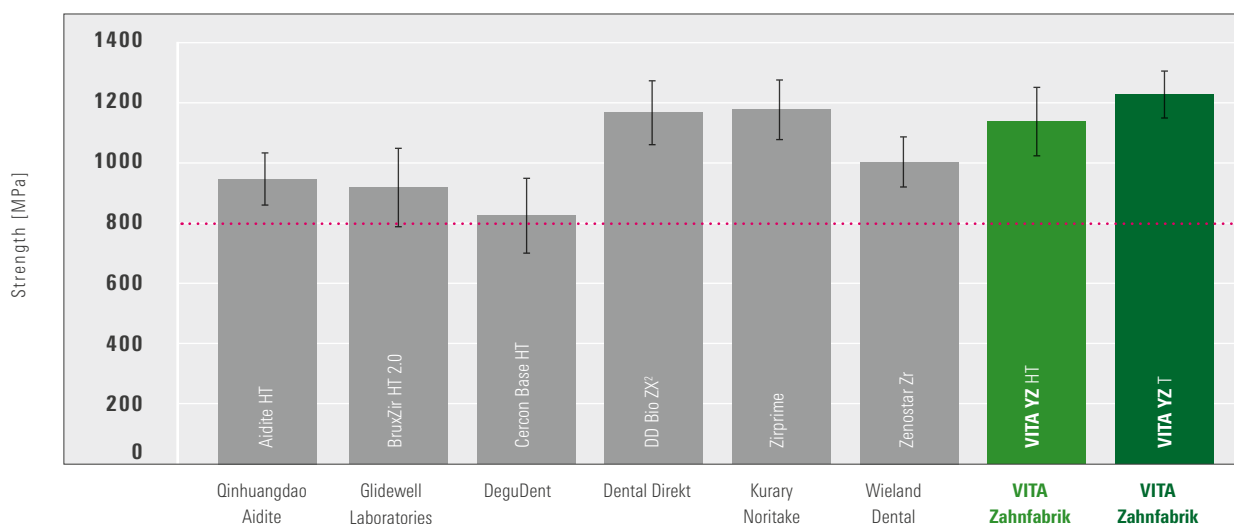
Comparison of 3-point flexural strength

..... Standard class 5 = 800 MPa

All zirconia materials examined in this test produced values above the standard requirement (> 800 MPa) for class 5. Compared to the competition, the strength values determined for VITA YZ SOLUTIONS were at a very high level. Determined strength differences may be a result of various materials that are not presintered equally, which can make sample preparation more difficult. To examine this, the dry green strength (= strength of the specimens in the presintered stage) of the materials was also examined. It ranged from 40 to 90 MPa, which suggests differences in the processing characteristics.

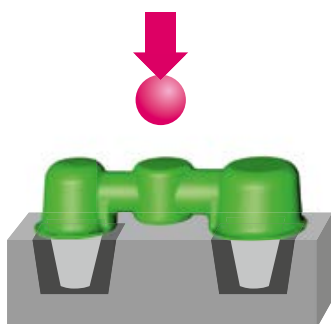
2.3 Static fracture load of different connector cross-sections

Stylized three-unit posterior bridges made of VITA YZ T, HT, ST and XT were fabricated using a CAM system and densely sintered, according to the manufacturer's instructions. The thinner "mesial" connector had a radius of 1.7 mm (~ 9.0 mm² cross-sectional area), the thicker "distal" a radius of 2.0 mm (~ 12.0 mm²). The bridges with an increased connector cross-section had radii of 2.0 mm ("mesial") and 2.3 m ("distal"). All abutments had a uniform wall thickness of 0.5 mm. All bridges were bonded to steel stumps using zinc-phosphate cement. For each material, six bridges with small connector cross-sections and six with increased connector cross-sections were loaded to fracture using a universal testing machine.

Fracture load – VITA YZ bridges with different connector cross-sections

All average values measured in this test, including the bridges with smaller connector cross-sections, were above the average maximum masticatory force with a value of approx. 490 N [5]. Fracture always occurred in the "gingival" area of the thinner ("mesial") connector under tensile stress, analogous to the 3-point bending test. The slight increase in the connector cross-section results in a considerably increased fracture load. It is therefore recommended to make the most of the available space when designing the connectors, in order to achieve a design with high load capacity. Based on this series of tests, a connector cross-section of at least 12 mm² in the molar area is recommended for VITA YZ XT (see Design recommendations – Working Instructions 10446M/1).

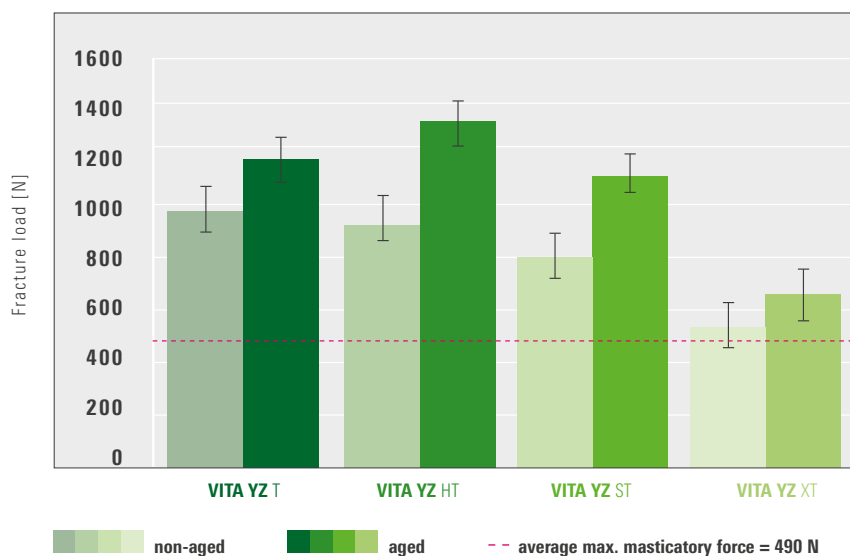
Fracture load – VITA YZ bridges before and after aging

For both simulated aging and non aged samples, mean values were reached that were above the maximum expected masticatory force [5], which suggests good long-term stability in the oral environment. The phenomenon of higher fracture loads after hydrothermal aging will be examined in future tests.

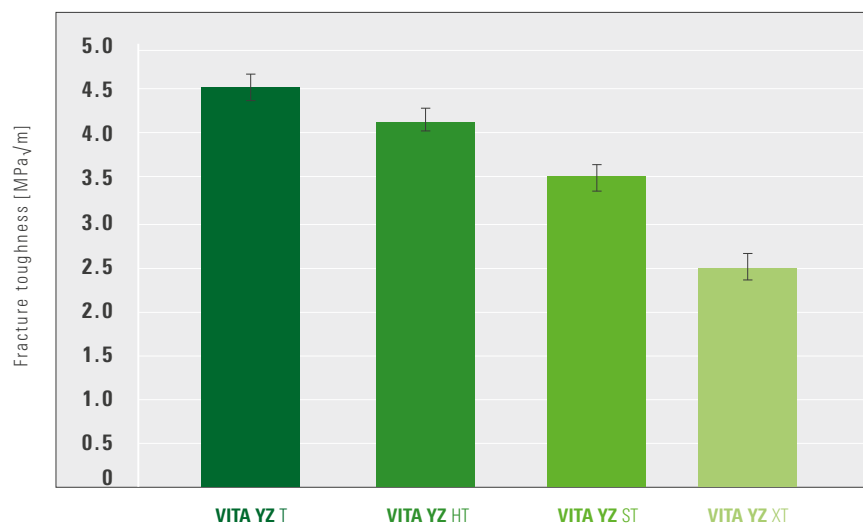
Fracture toughness of VITA YZ measured with the CNB method according to ISO 24370

The test shows a connection between chemical composition and mechanical resistance. Analogous to the increase in the yttrium oxide content (cf. Table 1.1 Chemical composition), the crack toughness of the different types decreases continuously. This is also reflected in the fracture load or the flexural strength of the materials. Current studies [12] put the main focus on influencing factors and the test methods for fracture toughness.

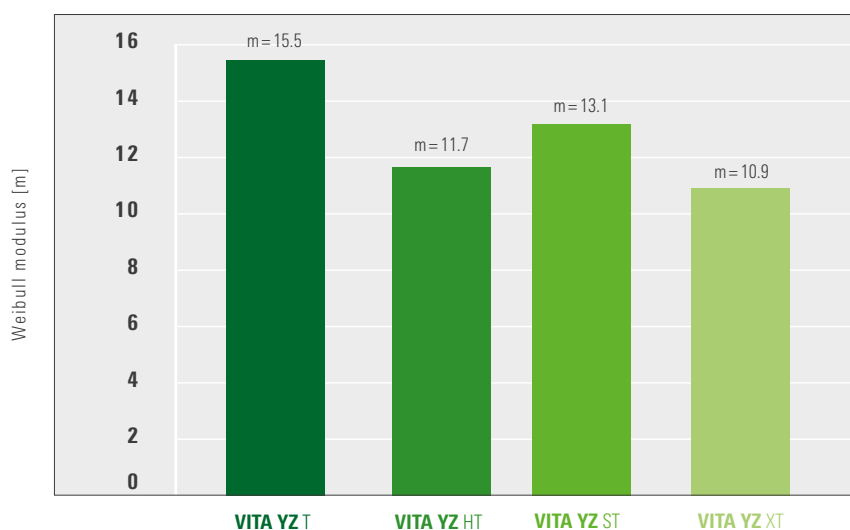
Weibull modulus of the different VITA YZ materials

In this test, excellent values were determined for the different VITA YZ materials with average values of the Weibull modulus from just under 11 to 16. The low deviation in the values measured is an indicator of high reliability and constant material quality. If only minor deviations from the average value (with respect to the determined minimum values) are measured, it can be expected that the material ensures reliable use within its respective recommended indication range.

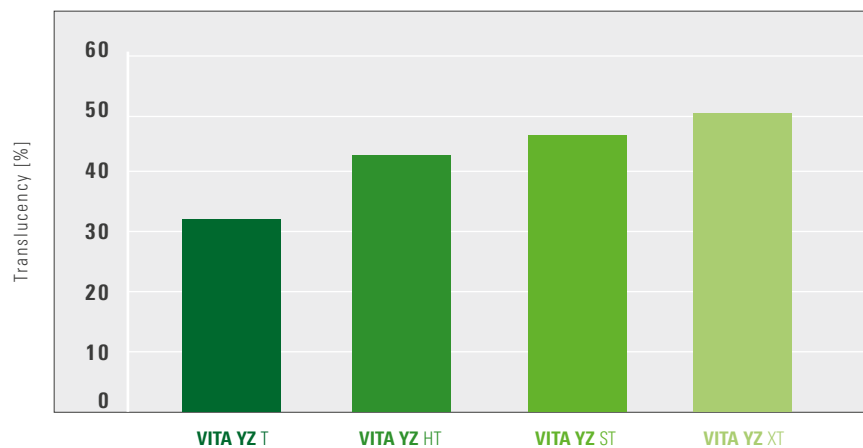
Translucency of the different VITA YZ materials

Average values with regard to the determined translucency		
VITA YZ T	32 %	
VITA YZ HT	42 %	
VITA YZ ST	46 %	
VITA YZ XT	50 %

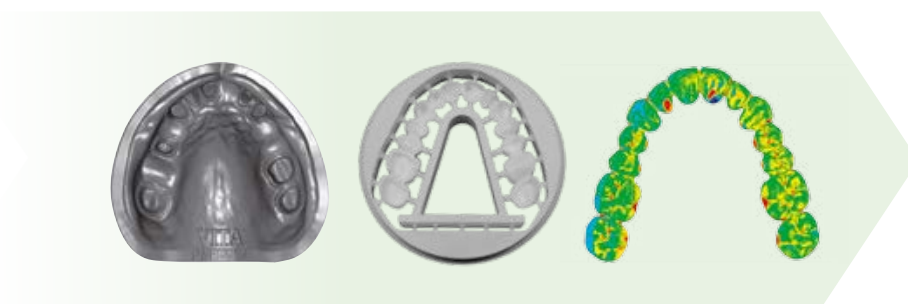
Figure 14a/b/c: a) model; b) milled, multi-unit VITA YZ structure; c) wrap software with overlapping structures (from left to right)

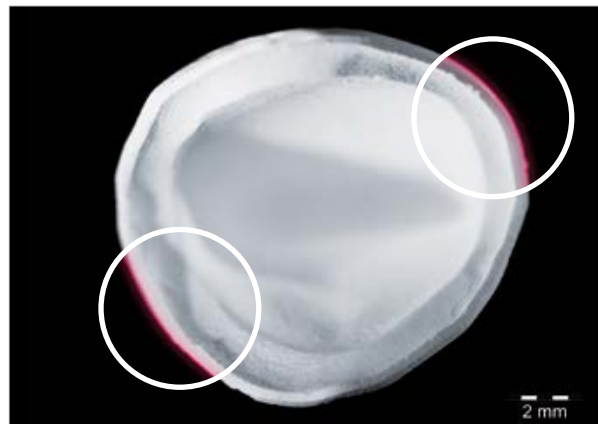
Figure 17: VITA YZ T (precolored material)

Based on a crown substructure, this test shows that the use of VITA YZ T enables the fabrication of extremely exact, precision-fit restorations, thanks to the high edge stability (cf. Fig. 17). In comparison, the competitor's material exhibits marginal fractures in some areas after the CAM process (cf. Fig. 18). VITA Zahnfabrik ensures that the raw breaking strength of the "white" product (presintered blank free of binders) for non- and precolored VITA YZ material types is at a similar level to enable users in practices and laboratories to achieve reproducible results, independent of the material type in use.

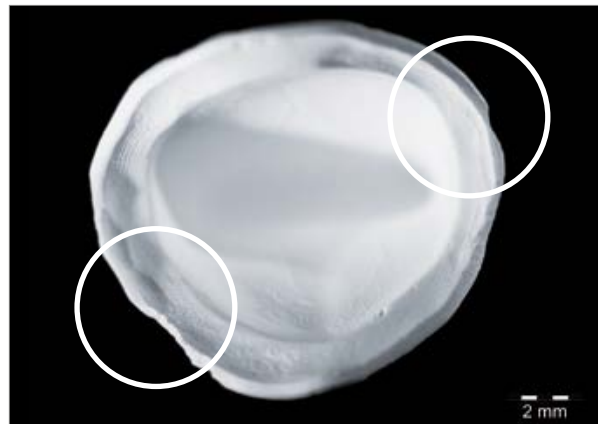
Figure 18: Competitor's zirconia (precolored material)

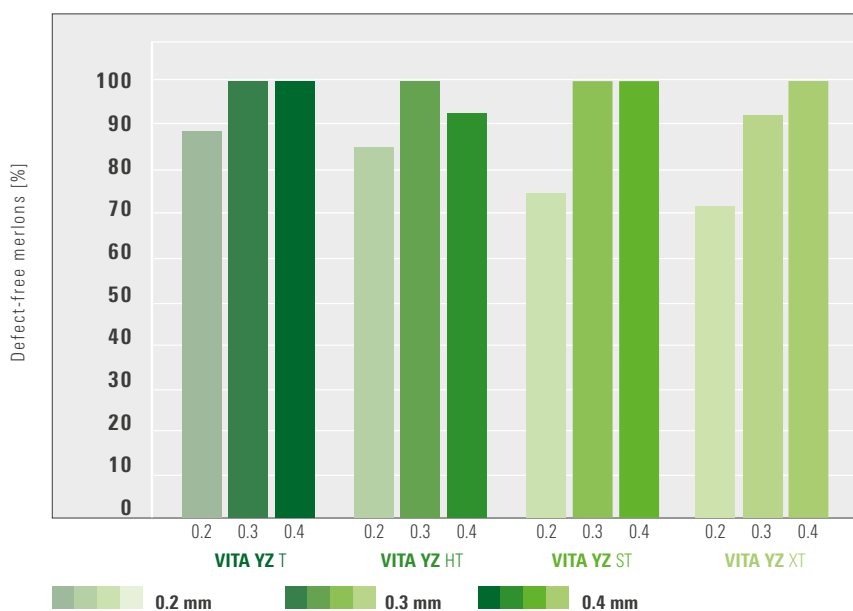
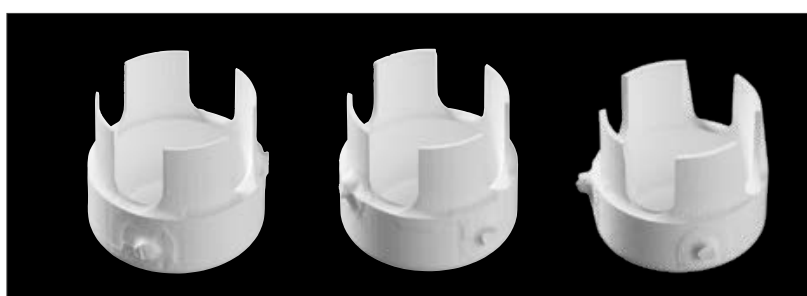
CAM machinability of the different VITA materials

Figure 19: "Merlon" geometries made of VITA YZ with wall thicknesses of 0.2 mm, 0.3 mm and 0.4 mm (from left to right))

This test shows that the use of all VITA YZ SOLUTION types enables the fabrication of extremely exact, precision-fit restorations, thanks to the high edge stability (cf. Fig. 19). However, with lower inherent strength, the survival rate decreases for particularly thin-walled geometries (cf. 0.2 mm), and the probability of a defect after CAM processing increases as a result.

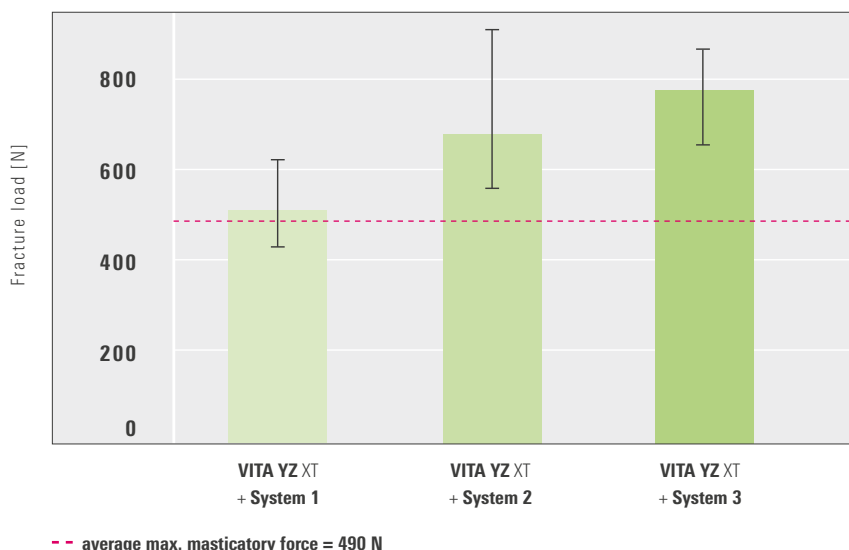
Fracture load after CAM fabrication with various systems

The result of this test shows that the CAD/CAM system used for the fabrication can have a significant influence on the fracture load of a bridge restoration. For example, both the parameters of the software (turning speed, feed rate, infeed) and the milling tools (type, condition) or the milling machine, can influence the surface quality of the restoration and its load capacity. The respective manufacturer's specifications (material and system manufacturer) must therefore be strictly observed for durable restorations. Recommendations on processing of VITA YZ are available at: www.vita-zahnfabrik.com

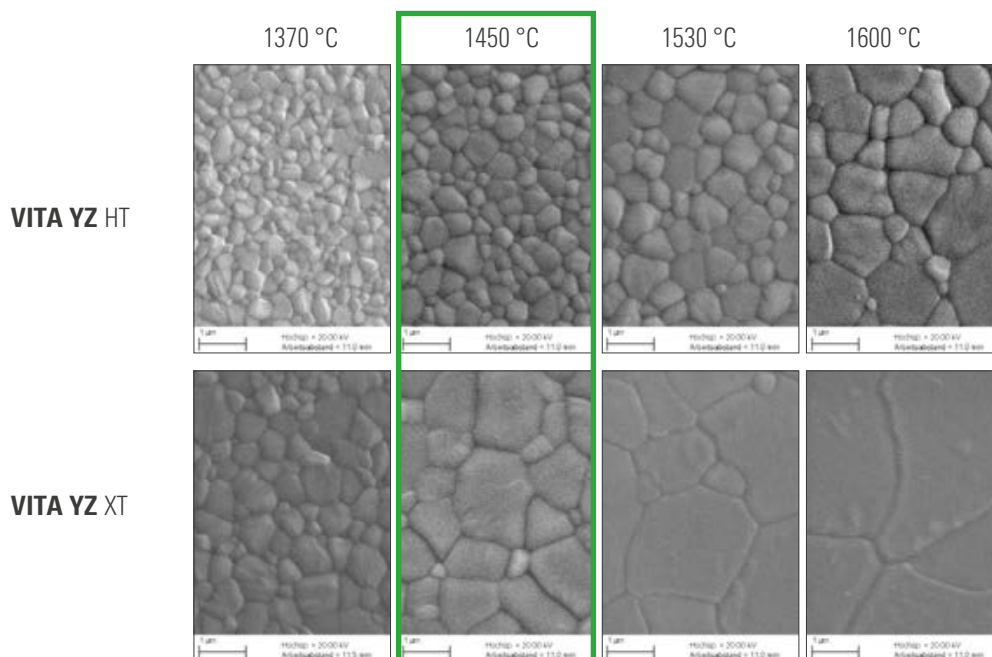
Figure 20: VITA YZ structure at various temperatures, magnification 20,000x

The ideal sintering temperature for VITA YZ HT and XT is 1450 °C, according to the manufacturer's recommendations. With this temperature, ideal optical and mechanical properties can be achieved for the named VITA YZ types. If VITA YZ is sintered at a higher temperature (e.g. at 1,600 °C), clearly visible grain growth occurs. Although this increases the translucency of the material, it also deteriorates its mechanical properties. In the case of VITA YZ XT, the temperature increase leads to a reduction in strength of approx. 100 MPa. It can also be assumed that the enormous grain growth will have a negative impact on the long-term load capacity as well.

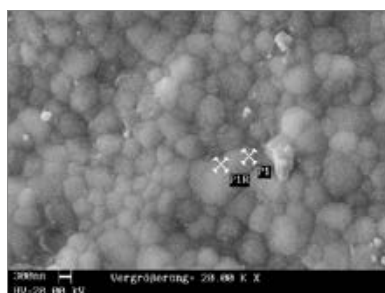
Figure 21a: Structure of VITA YZ T, conventionally sintered, magnification 20,000x

Equally good results can be achieved for VITA YZ T and VITA YZ HT with both conventional sintering (17 °C/min, 2 h holding time) and high speed sintering, with regard to structure, mechanical properties and fit. With the more translucent types VITA YZ ST and XT, a significant increase in opacity can be observed after high speed sintering with increasing yttrium content, which is why this sintering process cannot be recommended, particularly for esthetic reasons.

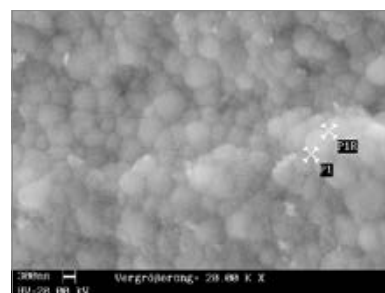
Figure 21b: Structure of VITA YZ T, high speed sintered, magnification 20,000x

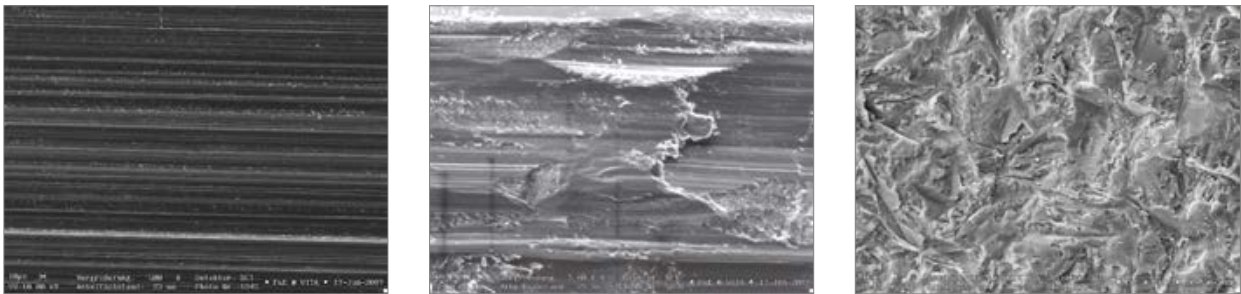
Figures 22 – 24: VITA YZ surfaces polished, adjusted with milling tools and sandblasted (from left to right), magnification 5,000x in each case

Different tools and methods cause different degrees of damage to zirconia surfaces (cf. Figs. 22 – 24). It is recommended to finish the dental object in the presintered stage (always from coarse to fine). Ideally, in the last step, the surfaces should be polished to minimize any defects on the surface. The sandblasting process by comparison, produces a rugged surface. The resulting defects might deteriorate the mechanical properties and cause stress in the bonding area towards the veneering ceramic.

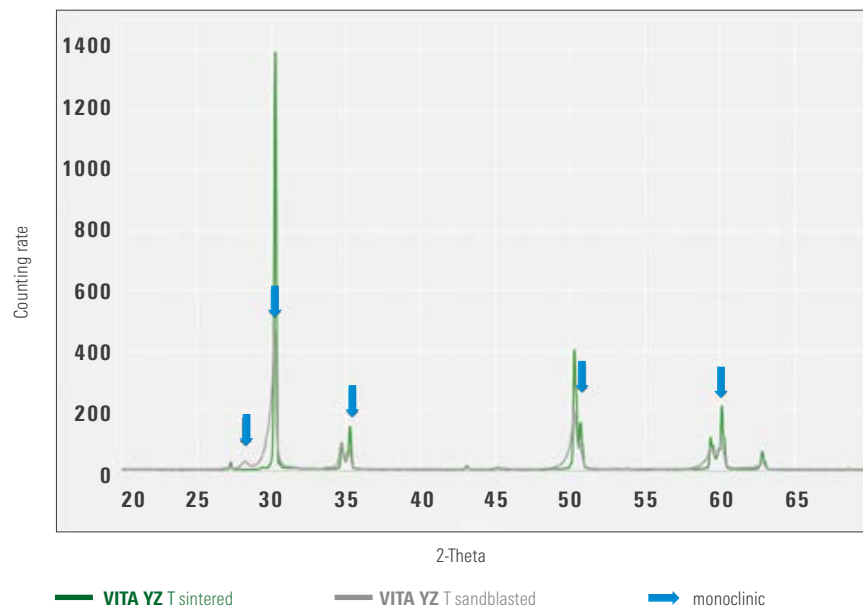
Diffractometer measurement of VITA YZ before and after sandblasting

The tetragonal zirconia lattice is transformed into a monoclinic crystal structure by sandblasting. Positive material properties, such as fracture toughness and aging resistance attributed to tetragonal modification, can no longer be ensured in this case. In addition, the monoclinic phase features a different CTE, which may result in unfavorable stress in the bonding area in combination with the veneering ceramic. Assumed positive effects of sandblasting, such as increasing the surface roughness, cannot be proven after the CAM process. As a result, it is unlikely that sandblasting will improve the wettability with veneering ceramic. For these reasons, it is recommended not to sandblast the surfaces to be veneered. However, sandblasting of the inner surfaces to improve the adhesive bond is possible and useful.

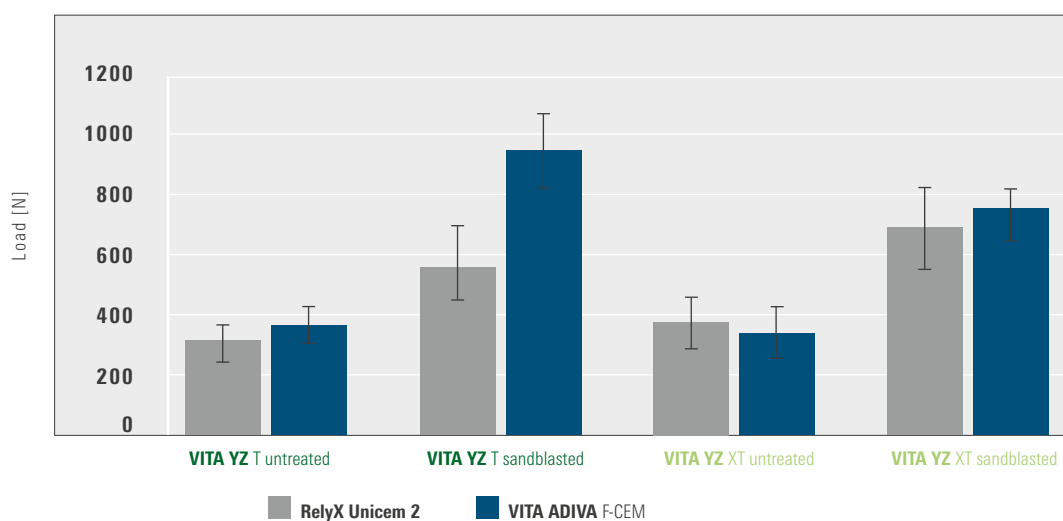
Compressive shear strength – bonding composites to VITA YZ types

The test results show that there is a significant increase in the compressive shear strength to VITA YZ after preconditioning by sandblasting. Sandblasting of the inner surfaces of the crown at a pressure of 2.0 bar and using 50 µm Al₂O₃ particles is therefore recommended. No significant differences in the determined compressive shear strength to VITA YZ T and VITA YZ XT were found. Significantly higher compressive shear strength values were determined only for the sandblasted VITA YZ T samples in combination with VITA ADIVA F-CEM. Overall, however, there is no significant difference between the two bonding systems with regard to the adhesive bond to VITA YZ.

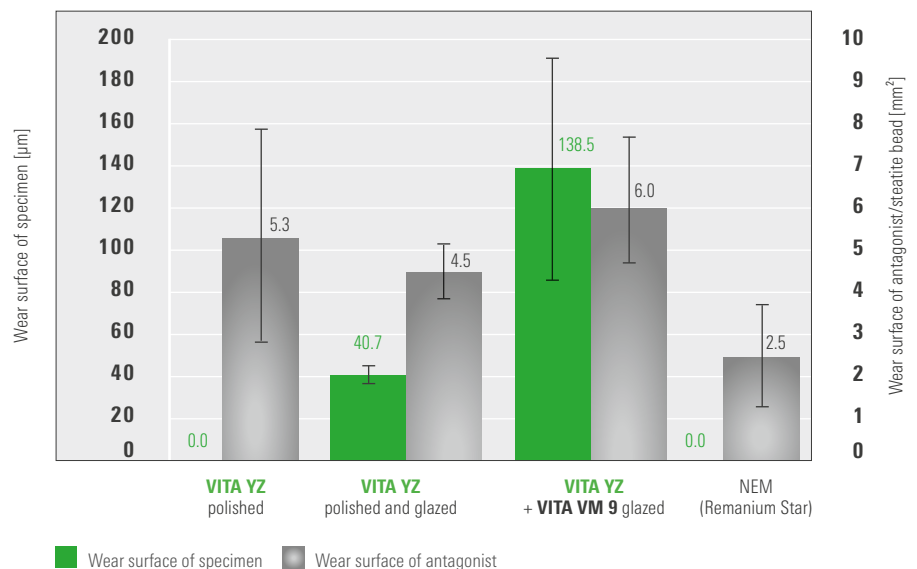
Abrasion tests

Material removal could not be measured for zirconia samples polished to high gloss (cf. test results for VITA YZ mentioned above) or for non-precious metal. If a glaze layer is applied to the VITA YZ samples, material removal can be measured again. The target of applying glaze material is to adjust the enamel-like abrasion behavior of dental zirconia restorations (cf. glazed VITA YZ samples). New in vivo studies indicate that no increased wear is expected on both the zirconia restoration and the antagonist, if appropriate surface quality is ensured.

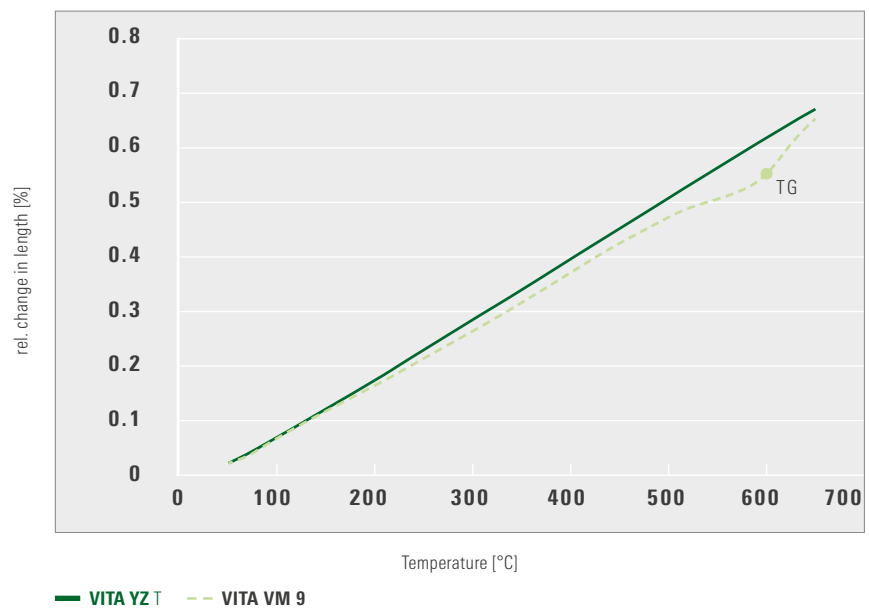
Thermal expansion of VITA YZ T and VITA VM 9

VITA YZ T has a CTE of approx. $10,5 \cdot 10^{-6} \cdot \text{K}^{-1}$. To ensure optimal stress ratios, the CTE of VITA VM 9 veneering material is slightly lower at approx. $9,2 \cdot 10^{-6} \cdot \text{K}^{-1}$. This is to ensure that long-term reliable bonding between the veneer and the substructure can be achieved. When using this measurement method, the determined glass transition temperature (TG) of the veneering material is approx. 600 °C.

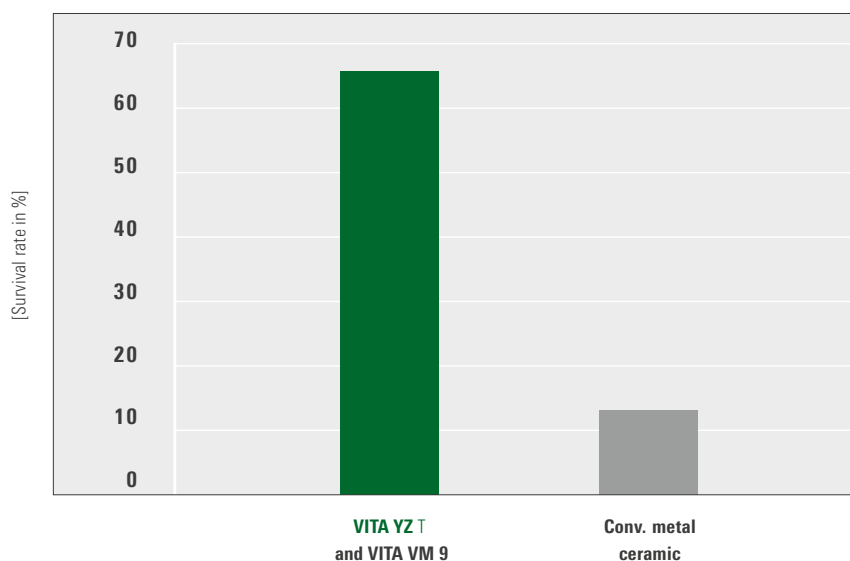
Thermal shock resistance

The higher the survival rate of the restorations used in this test, the lower the risk of crack formation or flaking of the veneering material based on long-term experience in daily use in practices/laboratories. In combination with VITA VM 9, VITA YZ T demonstrates a clearly higher survival rate than veneered metal ceramic in this test setup. The values determined for VITA YZ in combination with VITA VM 9 were compared with the average results of metal ceramic studies (various VMK generations in combination with various metal alloys) of past years.

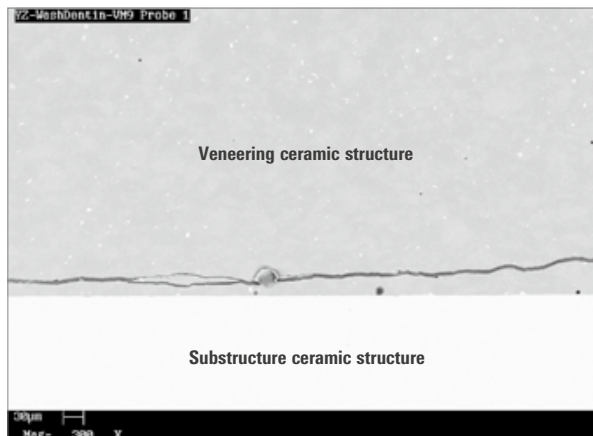
Figures 25 : VITA YZ T veneered with VITA VM 9, crack path in the veneer, magnification 300x

The bond of VITA YZ T to VITA VM 9 is regarded as excellent in the test series, since crack formation did not occur at all in the bonding area, but rather the cracks progressed through the layer of veneering material (cf. SEM picture; light gray substructure and dark gray veneering structure). Consequently, no measurable (energy) value of the actual bond can be determined.

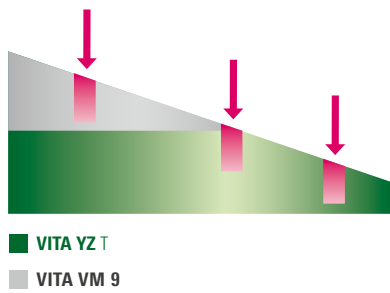
3.6 Bonding area between VITA YZ T and VITA VM 9

To examine the bonding area between VITA YZ T and VITA VM 9 closely, the VITA YZ T specimens were veneered with VITA VM 9 and subsequently sawed into wedges. Then the specimens were treated with VITA CERAMICS ETCH (hydrofluoric acid gel, 5 %) for 20 seconds and the surfaces were examined under a scanning electron microscope (SEM).

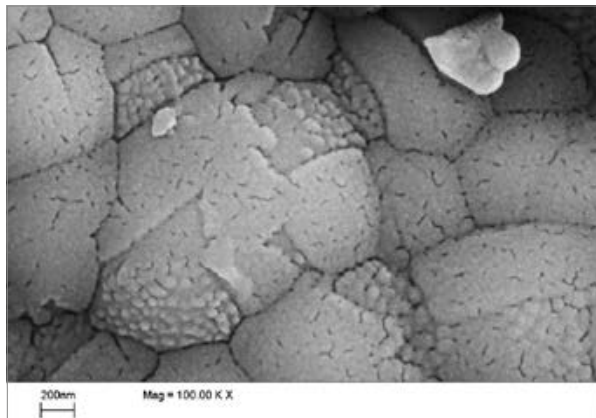
Figure 26: VITA YZ T structure after veneering, magnification 100,000x
