# VITA YZ® SOLUTIONS

Technical and scientific documentation

Date of issue 2024-12

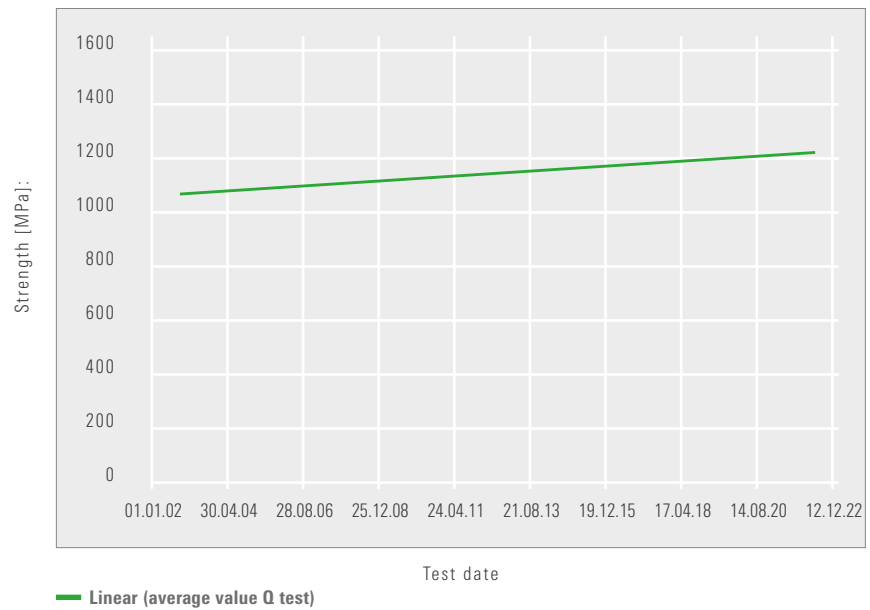
**Figure 1:** Flexural strength values from 2002 to 2022; determined within the scope of internal quality tests, source: Internal study, VITA R&D, (Gödiker, 12/2022, [1] see p. 35)

One example is the improvement of mechanical properties of VITA YZ T, such as the 3-point flexural strength (see Fig. 1). This documentation provides an overview of the most important technical and scientific data of VITA YZ SOLUTIONS.

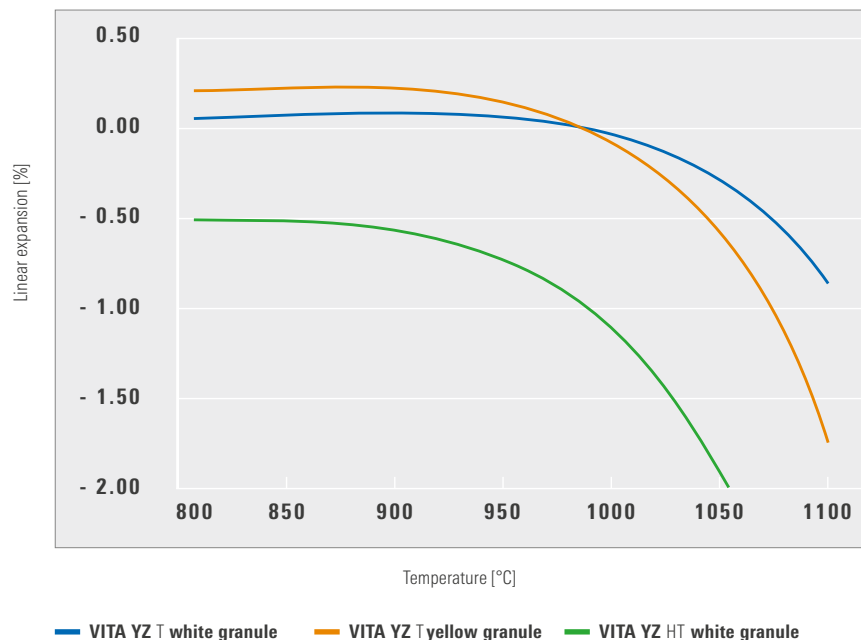
#### Dilatometer measurements of various zirconia granules in the range of the presintering temperature

**Figure 2:** Study of the sintering behavior of various VITA YZ granules

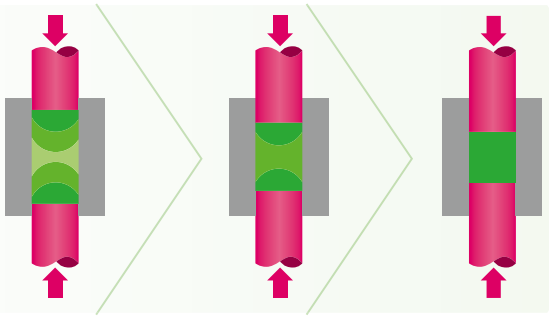
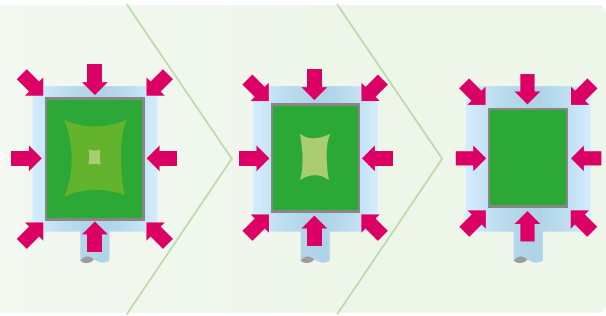
**Step 1: Pressing process, uniaxial, two-sided**

**Step 2: Pressing process, isostatic**

**Figure 3:** Schematic view of the pressing process for VITA YZ SOLUTIONS blanks

First, the basic shape of the zirconia blanks of VITA Zahnfabrik is achieved in a uniaxial pressing process and then the blanks are repressed isostatically in a high pressure container. The homogeneous density that is achieved is an essential precondition for homogeneous sintering behavior. The presintering process - that is, the industrial firing process - is precisely adjusted to the respective batch and blank geometry.

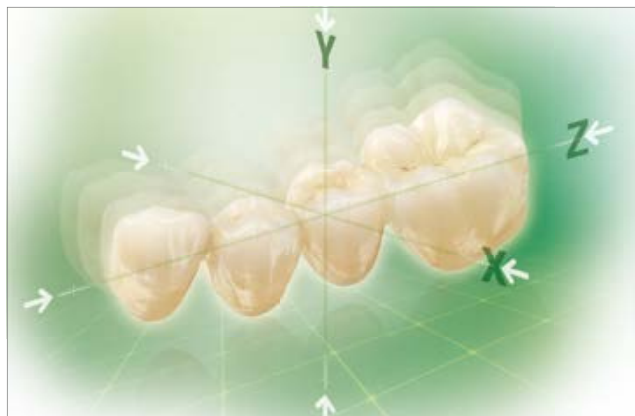
**Figure 4:** Example of sintering shrinkage (X-, Y-, Z-dimension)

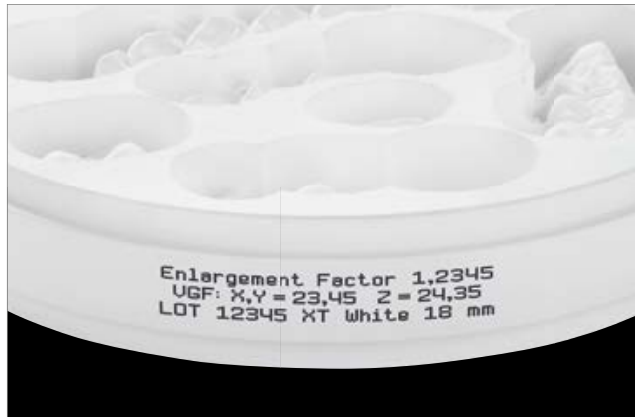
**Figure 5:** Example of enlargement factors indicated on blanks

Another essential step in accessing accurate sintering results is the precise determination of the enlargement factor. VITA Zahnfabrik determines this factor in all three spatial dimensions (X-, Y-, Z-dimension) for each production batch and integrates the information in the print on the blank (as a bar code or plain text). Some manufacturers, however, only indicate average values. Exact determination of sintering shrinkage and the precision of fit of the densely sintered dental object is particularly essential for multi-unit bridge constructions.

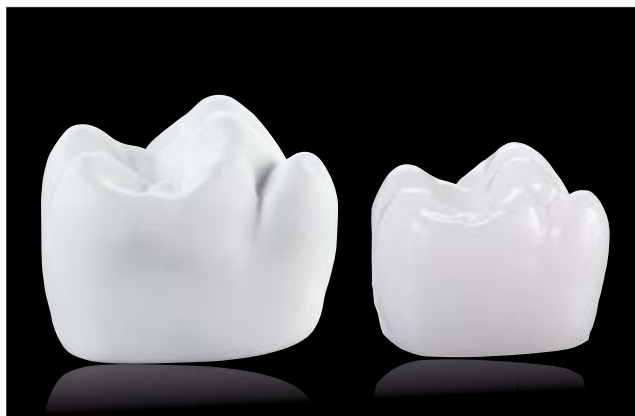
**Figure 6:** Example of sintering shrinkage of zirconia by approx. 20 %

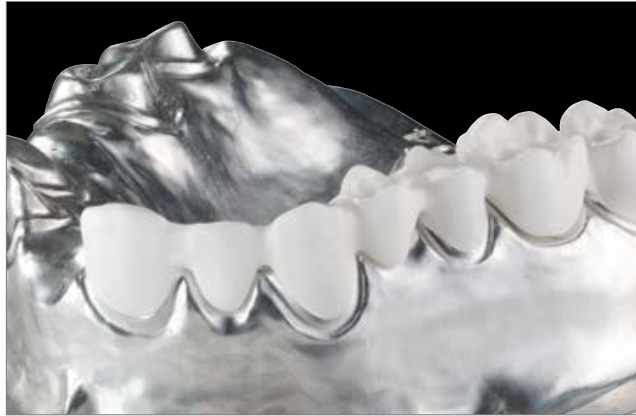
**Figure7:** Example of test fit with model made of metal

The final quality inspection at VITA is carried out using a pass or fail of the test fit. For this purpose, a bridge structure with a maximum size indicated for the respective material is fabricated (CAD/CAM fabrication) using the enlargement factor determined for each batch; the structure is densely sintered and the fit is checked (see 2.8) on a standardized steel model (see Fig. 7).

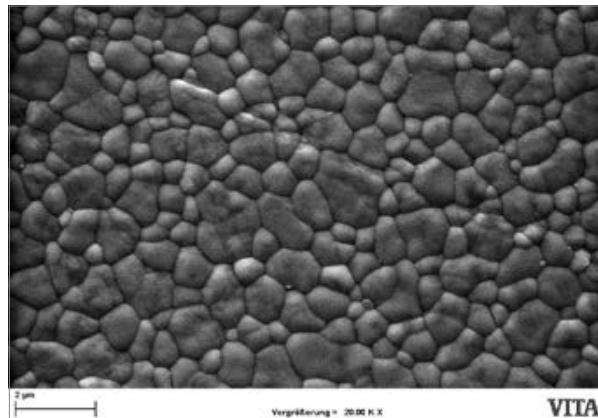
Figure 8: VITA YZ T at 20,000x magnification

Based on particularly high quality standards, VITA YZ features a homogeneous microstructure without pores or defects (see Fig. 8). The sintered microstructure features an average particle size of approx. 500 nm. Contamination and structural defects can sometimes be found (see Fig. 9) in low-quality zirconia blanks (often low price products). Some defects, however, can only be detected at high magnification.

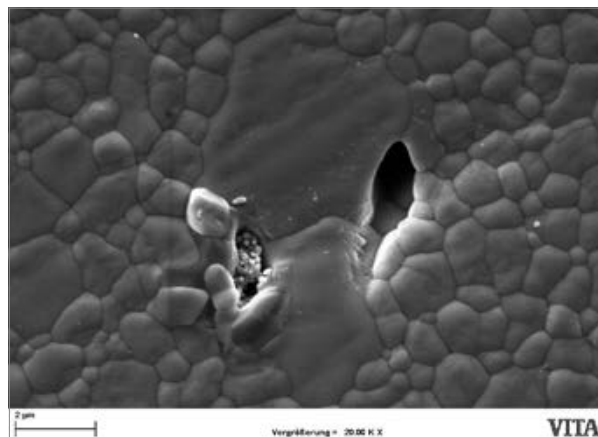
Figure 9: Competitor's zirconia at 20,000x magnification

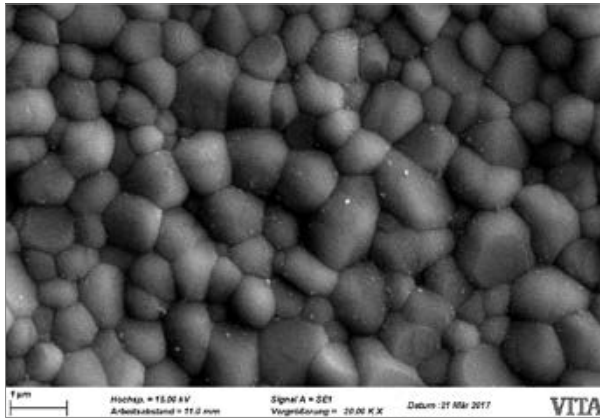
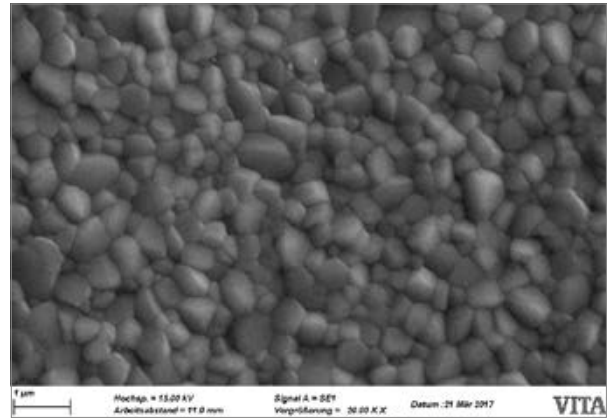
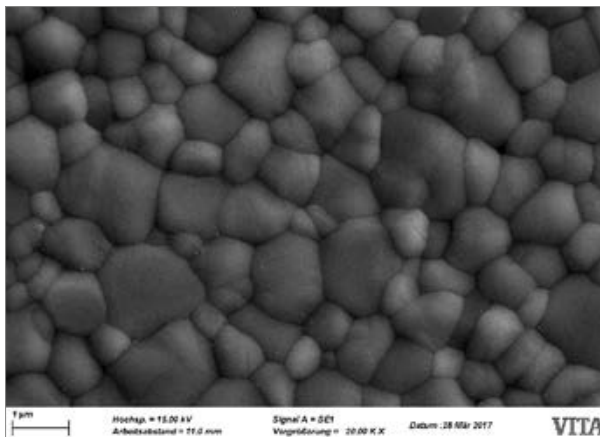
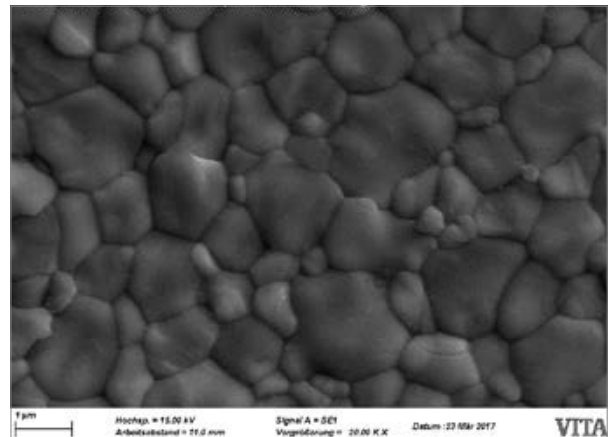
Figure 10: VITA YZ T at 20,000x magnification

Figure 11: VITA YZ HT at 20,000x magnification

Figure 12: VITA YZ ST at 20,000x magnification

Figure 13: VITA YZ XT at 20,000x magnification

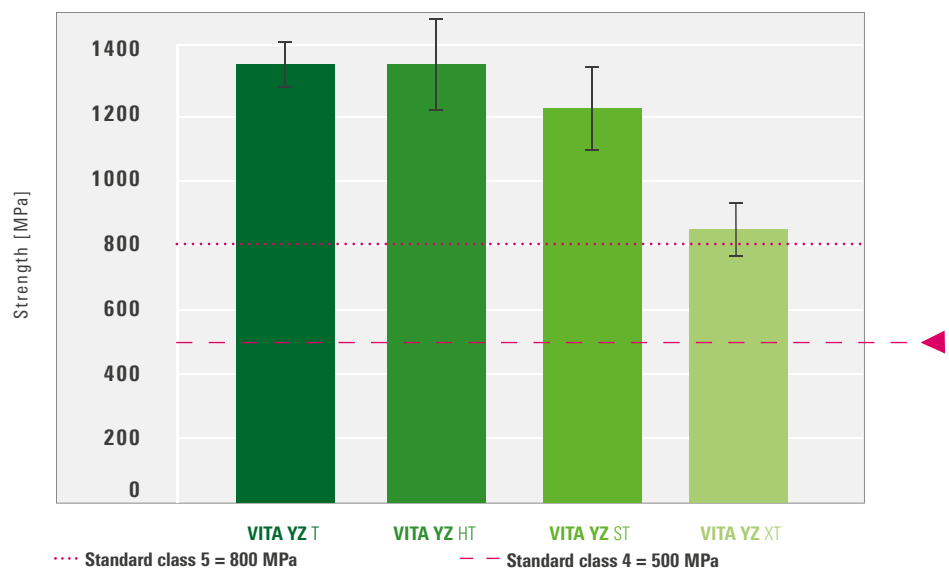
##### 3-point flexural strength of the different VITA YZ materials

#### Standard class 4<sup>1)</sup>: ≥ 500 MPa

In this test setup, VITA YZ XT achieved an average value of 850 MPa. Due to the lower fracture toughness (see point 2.5), the recommendation for indications corresponds to class 4.

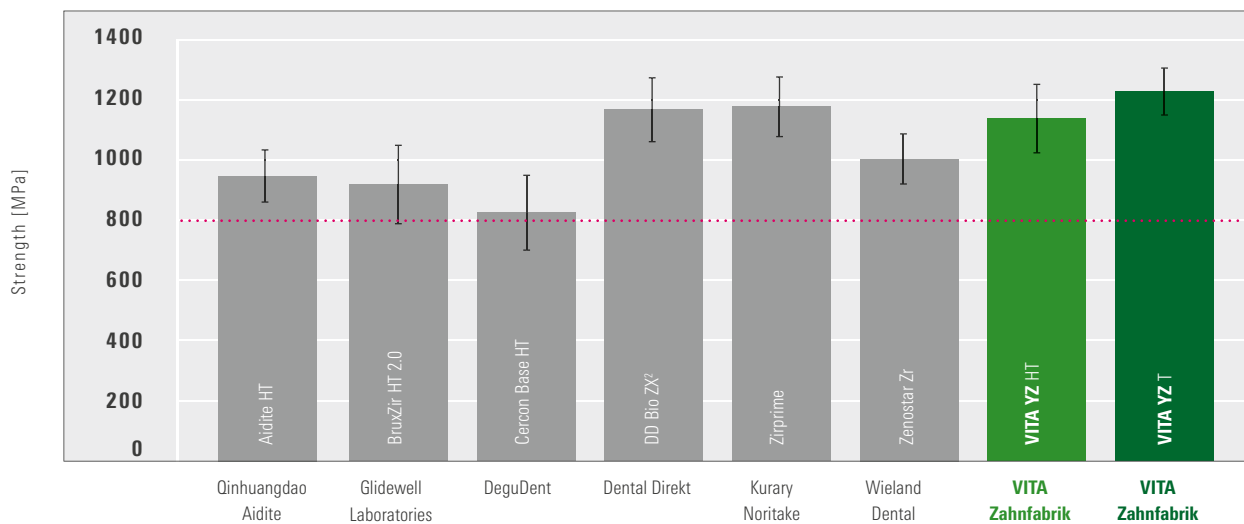
Comparison of 3-point flexural strength

..... Standard class 5 = 800 MPa

All zirconia materials examined in this test produced values above the standard requirement (> 800 MPa) for class 5. Compared to the competition, the strength values determined for VITA YZ SOLUTIONS were at a very high level. Determined strength differences may be a result of various materials that are not presintered equally, which can make sample preparation more difficult. To examine this, the dry green strength (= strength of the specimens in the presintered stage) of the materials was also examined. It ranged from 40 to 90 MPa, which suggests differences in the processing characteristics.

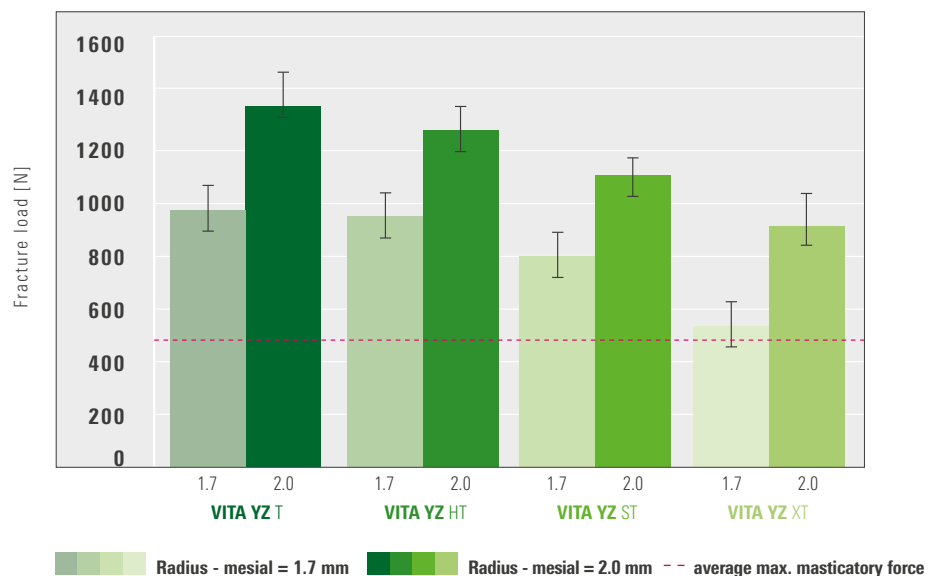
#### Fracture load - VITA YZ bridges with different connector cross-sections

All average values measured in this test, including the bridges with smaller connector cross-sections, were above the average maximum masticatory force with a value of approx. 490 N [5]. Fracture always occurred in the "gingival" area of the thinner ("mesial") connector under tensile stress, analogous to the 3-point bending test. The slight increase in the connector cross-section results in a considerably increased fracture load. It is therefore recommended to make the most of the available space when designing the connectors, in order to achieve a design with high load capacity. Based on this series of tests, a connector cross-section of at least 12 mm<sup>2</sup> in the molar area is recommended for VITA YZ XT (see Design recommendations - Working Instructions 10446M/1).

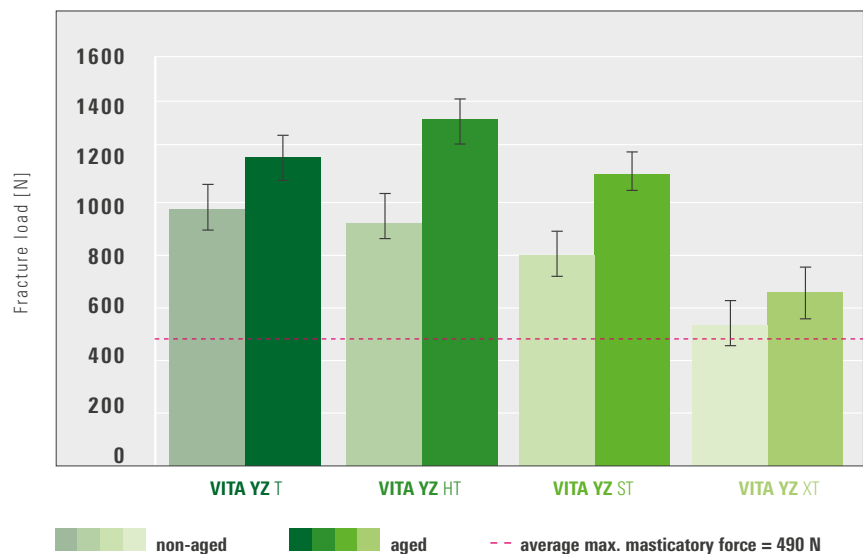
Fracture load - VITA YZ bridges before and after aging

For both simulated aging and non-aged samples, mean values were reached that were above the maximum expected masticatory force [5], which suggests good long-term stability in the oral environment. The phenomenon of higher fracture loads after hydrothermal aging will be examined in future tests.

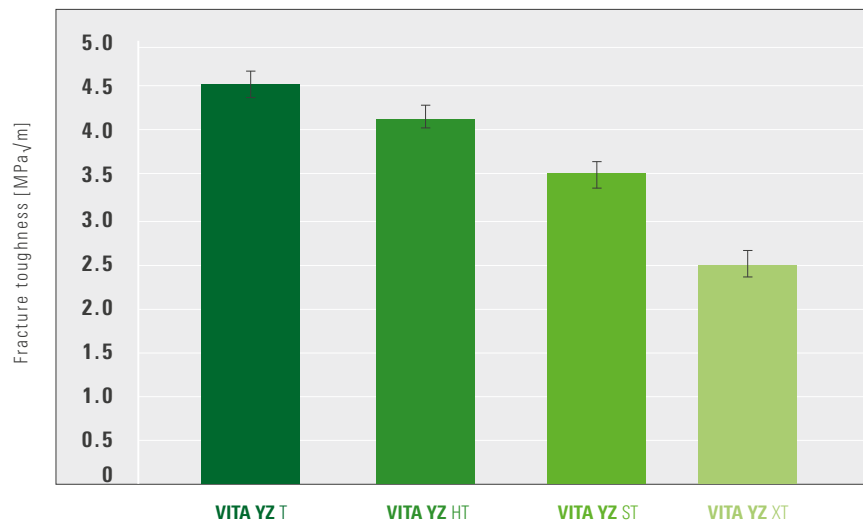
#### Fracture toughness of VITA YZ measured with the CNB method according to ISO 24370

The test shows a connection between chemical composition and mechanical resistance. Analogous to the increase in the yttrium oxide content (see Table 1.1 Chemical composition), the crack toughness of the different types decreases continuously. This is also reflected in the fracture load or the flexural strength of the materials. Current studies [12] put the main focus on influencing factors and the test methods for fracture toughness.

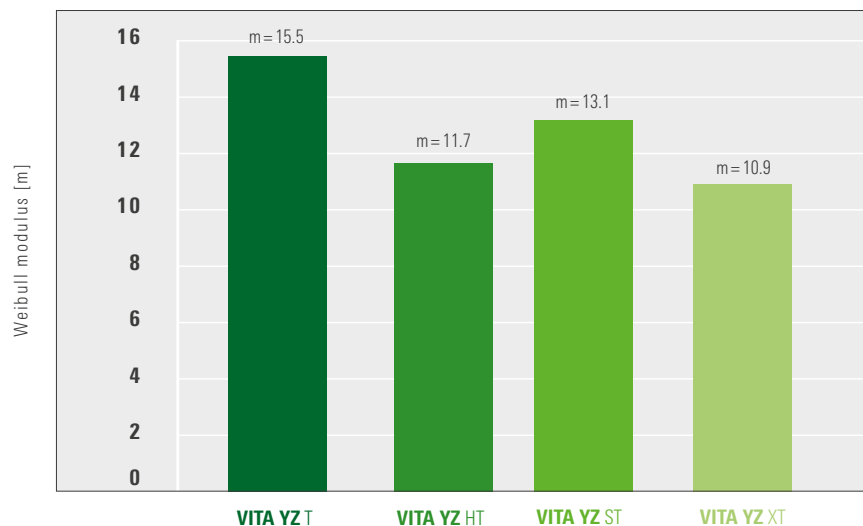
#### Weibull modulus of the different VITA YZ materials

In this test, excellent values were determined for the different VITA YZ materials with average values of the Weibull modulus from just under 11 to 16. The low deviation in the values measured is an indicator of high reliability and constant material quality. If only minor deviations from the average value (with respect to the determined minimum values) are measured, it can be expected that the material ensures reliable use within its respective recommended indication range.

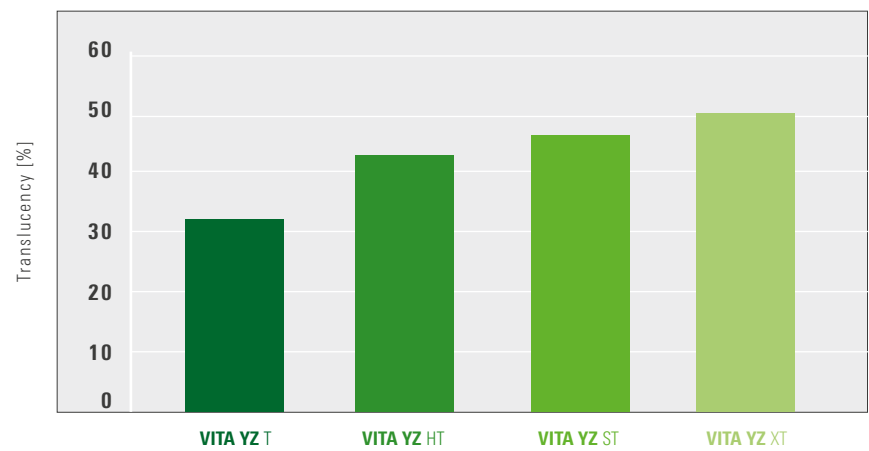
Translucency of the different VITA YZ materials

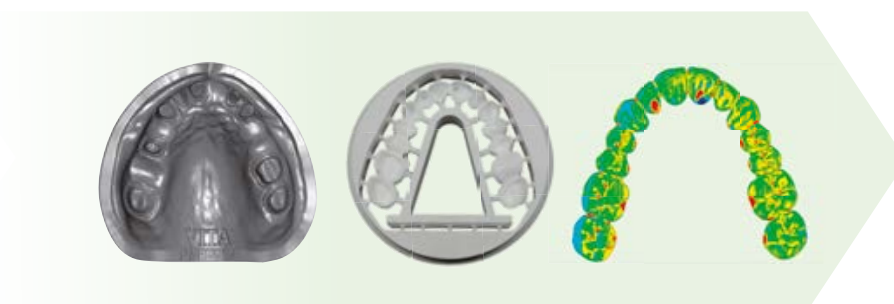
**Figure 14a/b/c:** a) model; b) milled, multi-unit VITA YZ structure; c) wrap software with overlapping structures (from left to right)

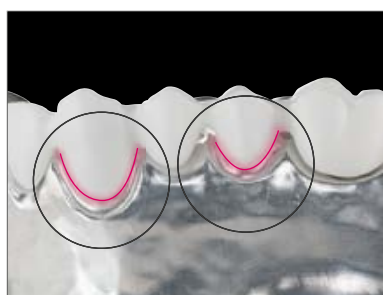
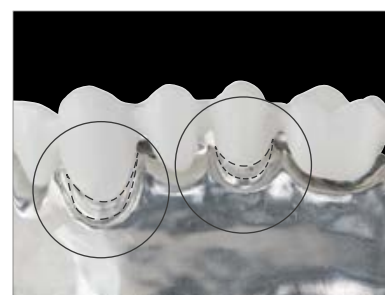
**Figure 15/16:** Visual fit check after sintering process using a control model for VITA YZ T/competitors

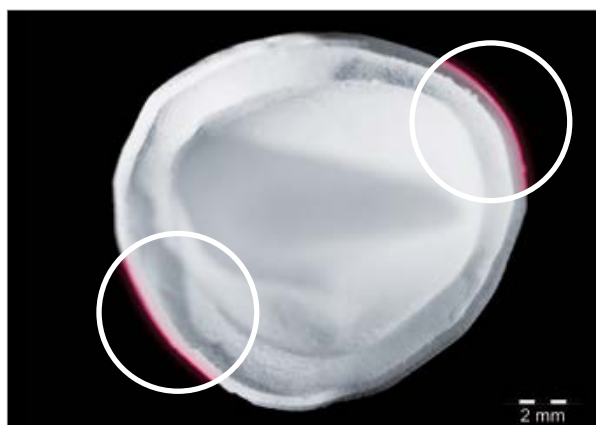
Figure 17: VITA YZ T (pre-colored material)

Based on a crown substructure, this test shows that the use of VITA YZ T enables the fabrication of extremely exact, precision-fit restorations, thanks to the high edge stability (see Fig. 17). In comparison, the competitor's material exhibits marginal fractures in some areas after the CAM process (see Fig. 18). VITA Zahnfabrik ensures that the raw breaking strength of the "white" product (presintered blank free of binders) for non- and pre-colored VITA YZ material types is at a similar level to enable users in practices and laboratories to achieve reproducible results, independent of the material type in use.

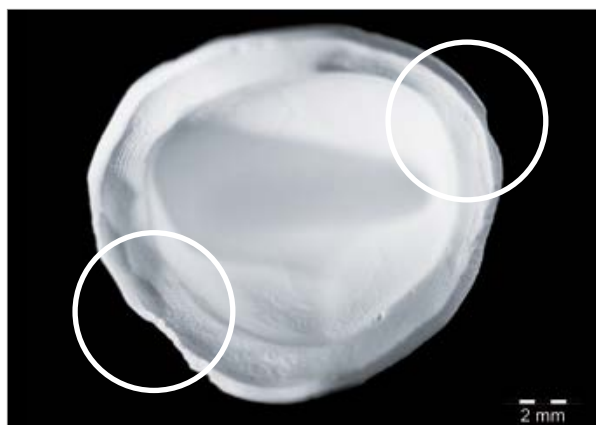
Figure 18: Competitor's zirconia (pre-colored material)

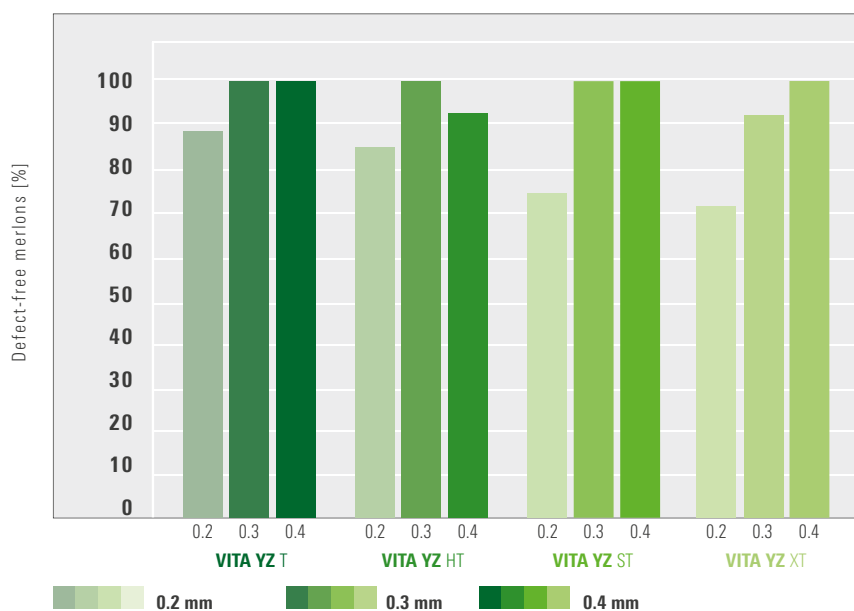
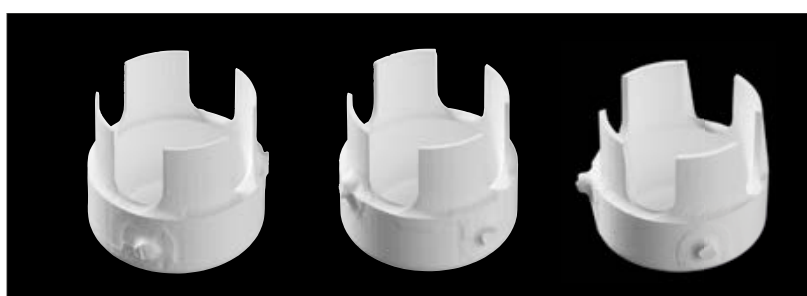
#### CAM machinability of the different VITA materials

Figure 19: "Merlon" geometries made of VITA YZ with wall thicknesses of 0.2 mm, 0.3 mm and 0.4 mm (from left to right))

This test shows that the use of all VITA YZ SOLUTION types enables the fabrication of extremely exact, precision-fit restorations, thanks to the high edge stability (see Fig. 19). However, with lower inherent strength, the survival rate decreases for particularly thin-walled geometries (see 0.2 mm), and the probability of a defect after CAM processing increases as a result.

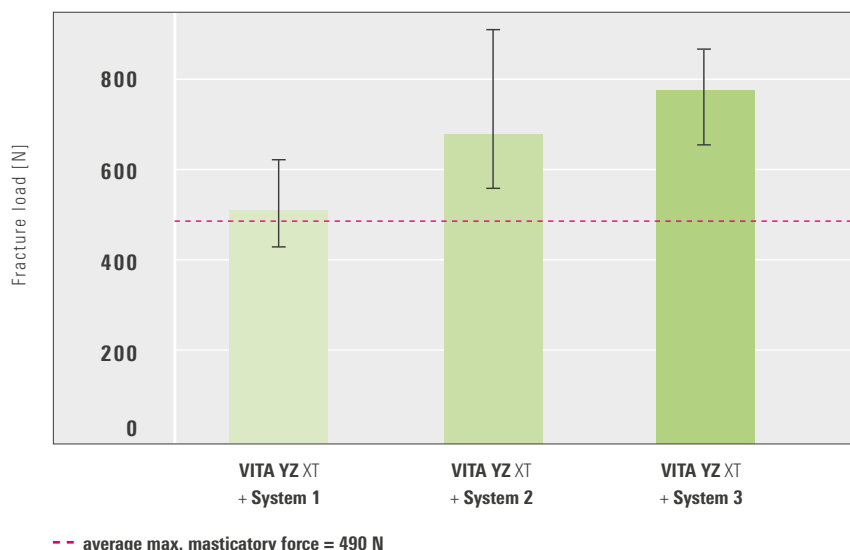
#### Fracture load after CAM fabrication with various systems

The result of this test shows that the CAD/CAM system used for the fabrication can have a significant influence on the fracture load of a bridge restoration. For example, both the parameters of the software (turning speed, feed rate, infeed) and the milling tools (type, condition) or the milling machine, can influence the surface quality of the restoration and its load capacity. The respective manufacturers' specifications (material and system manufacturer) must therefore be strictly observed for durable restorations. Recommendations on processing of VITA YZ are available at: [www.vita-zahnfabrik.com](http://www.vita-zahnfabrik.com)

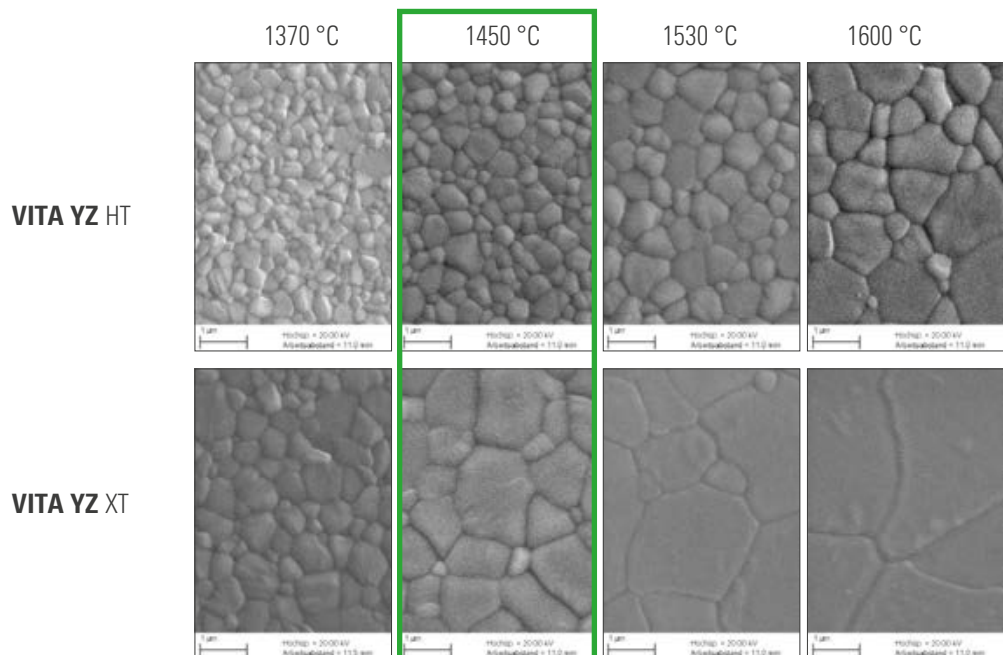
Figure 20: VITA YZ structure at various temperatures, magnification 20,000x

The ideal sintering temperature for VITA YZ HT and XT is 1450 °C, according to the manufacturer's recommendations. With this temperature, ideal optical and mechanical properties can be achieved for the named VITA YZ types. If VITA YZ is sintered at a higher temperature (e.g., at 1600 °C), clearly visible grain growth occurs. Although this increases the translucency of the material, it also deteriorates its mechanical properties. In the case of VITA YZ XT, the temperature increase leads to a reduction in strength of approx. 100 MPa. It can also be assumed that the enormous grain growth will have a negative impact on the long-term load capacity as well.

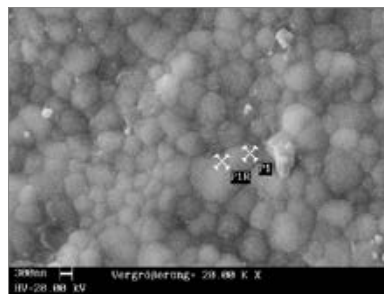
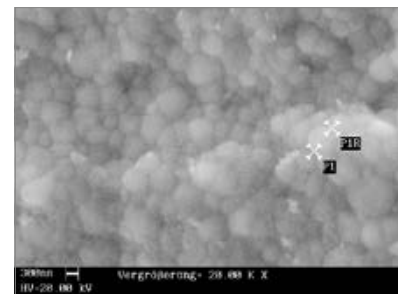
**Figure 21a:** Structure of VITA YZ T, conventionally sintered, magnification 20,000x

**Figure 21b:** Structure of VITA YZ T, high speed sintered, magnification 20,000x

Equally good results can be achieved for VITA YZ T and VITA YZ HT with both conventional sintering (17 °C/min, 2 h holding time) and high speed sintering, with regard to structure, mechanical properties and fit. With the more translucent types VITA YZ ST and XT, a significant increase in opacity can be observed after high speed sintering with increasing yttrium content, which is why this sintering process cannot be recommended, particularly for esthetic reasons.

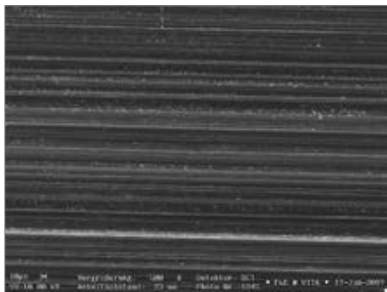
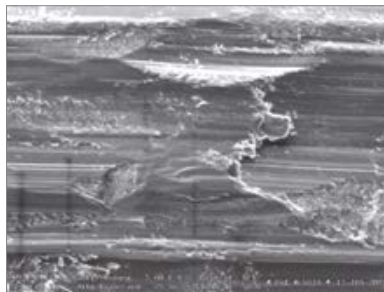
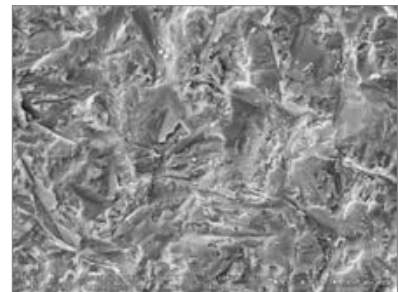
Figures 22 – 24: VITA YZ surfaces polished, adjusted with milling tools and sandblasted (from left to right), magnification 5,000x in each case

Different tools and methods cause different degrees of damage to zirconia surfaces (see Figs. 22 - 24). It is recommended to finish the dental object in the presintered stage (always from coarse to fine). Ideally, in the last step, the surfaces should be polished to minimize any defects on the surface. The sandblasting process by comparison, produces a rugged surface. The resulting defects might deteriorate the mechanical properties and cause stress in the bonding area towards the veneering ceramic.

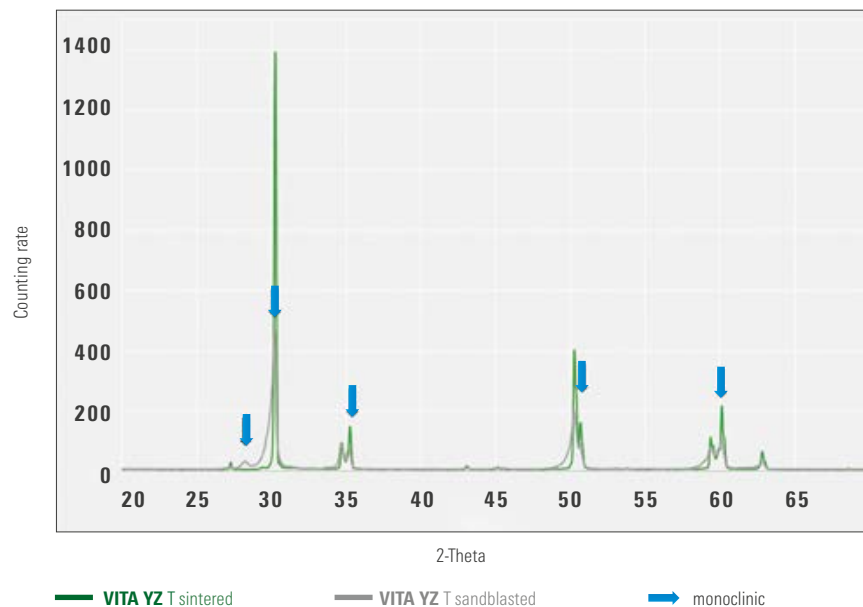
#### Diffractometer measurement of VITA YZ before and after sandblasting

The tetragonal zirconia lattice is transformed into a monoclinic crystal structure by sandblasting. Positive material properties, such as fracture toughness and aging resistance attributed to tetragonal modification, can no longer be ensured in this case. In addition, the monoclinic phase features a different CTE, which may result in unfavorable stress in the bonding area in combination with the veneering ceramic. Assumed positive effects of sandblasting, such as increasing the surface roughness, cannot be proven after the CAM process. As a result, it is unlikely that sandblasting will improve the wettability with veneering ceramic. For these reasons, it is recommended not to sandblast the surfaces to be veneered. However, sandblasting of the inner surfaces to improve the adhesive bond is possible and useful.

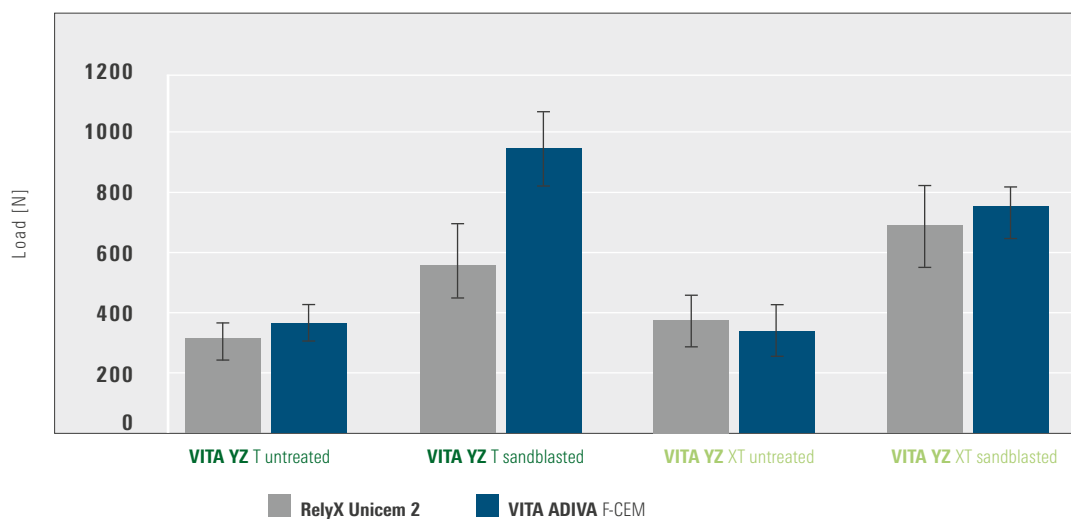
Compressive shear strength - bonding composites to VITA YZ types

The test results show that there is a significant increase in the compressive shear strength to VITA YZ after preconditioning by sandblasting. Sandblasting of the inner surfaces of the crown at a pressure of 2.0 bar and using 50 µm Al<sub>2</sub>O<sub>3</sub> particles is therefore recommended. No significant differences in the determined compressive shear strength to VITA YZ T and VITA YZ XT were found. Significantly higher compressive shear strength values were determined only for the sandblasted VITA YZ T samples in combination with VITA ADIVA F-CEM. Overall, however, there is no significant difference between the two bonding systems with regard to the adhesive bond to VITA YZ.

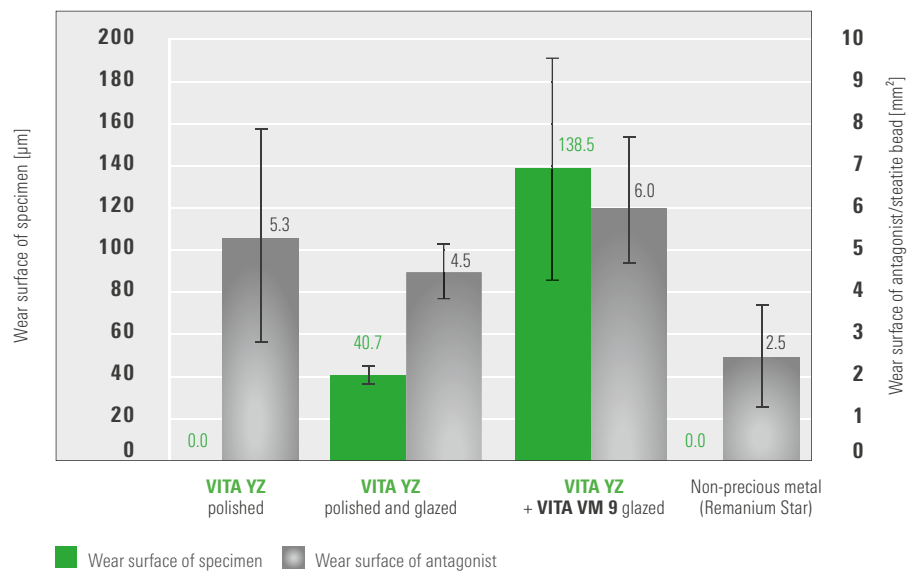
##### Abrasion tests

Material removal could not be measured for zirconia samples polished to high gloss (see test results for VITA YZ mentioned above) or for non-precious metal. If a glaze layer is applied to the VITA YZ samples, material removal can be measured again. The target of applying glaze material is to adjust the enamel-like abrasion behavior of dental zirconia restorations (see glazed VITA YZ samples). New in vivo studies indicate that no increased wear is expected on both the zirconia restoration and the antagonist, if appropriate surface quality is ensured.

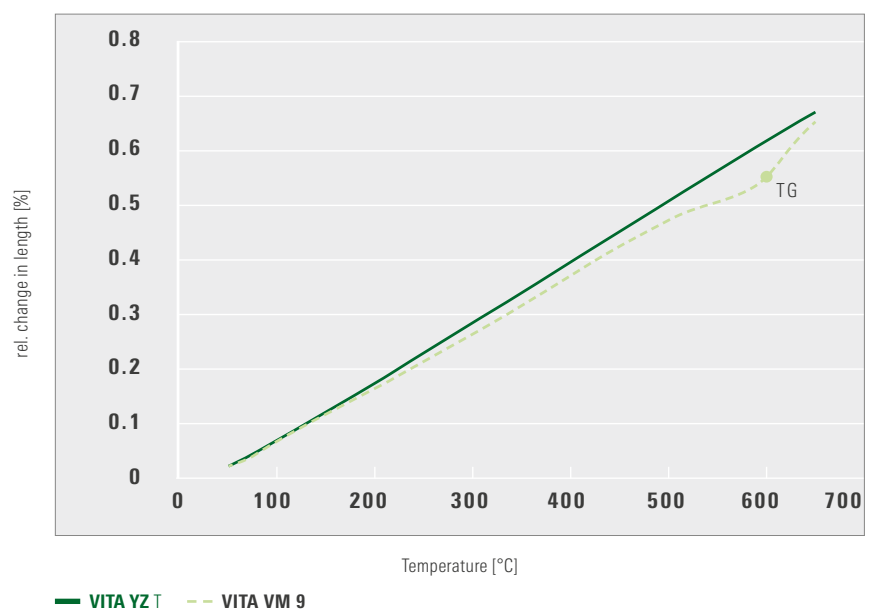
#### Thermal expansion of VITA YZ T and VITA VM 9

VITA YZ T has a CTE of approx.  $10.5 \cdot 10^{-6} \cdot \text{K}^{-1}$ . To ensure optimal stress ratios, the CTE of VITA VM 9 veneering material is slightly lower at approx.  $9.2 \cdot 10^{-6} \cdot \text{K}^{-1}$ . This is to ensure that long-term reliable bonding between the veneer and the substructure can be achieved. When using this measurement method, the determined glass transition temperature (TG) of the veneering material is approx. 600 °C.

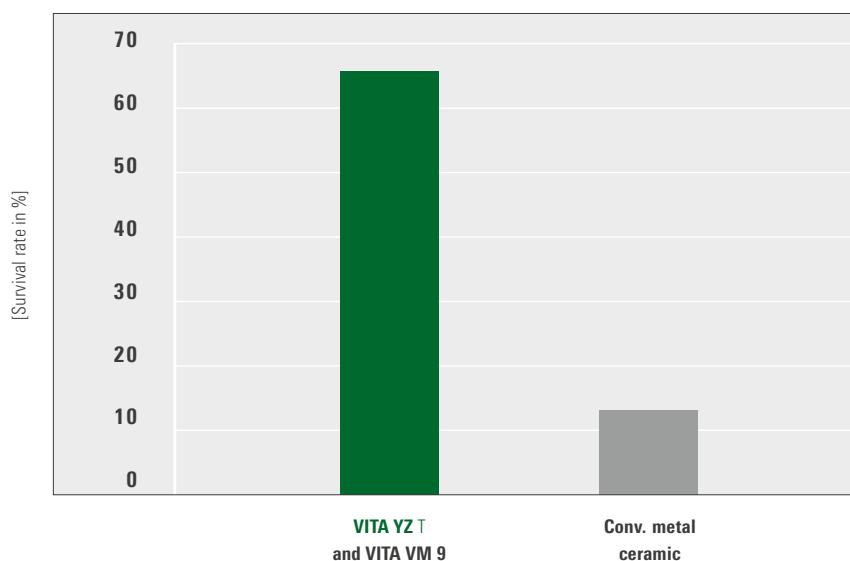
##### Thermal shock resistance

The higher the survival rate of the restorations used in this test, the lower the risk of crack formation or flaking of the veneering material based on long-term experience in daily use in practices/laboratories. In combination with VITA VM 9, VITA YZ T demonstrates a clearly higher survival rate than veneered metal ceramic in this test setup. The values determined for VITA YZ in combination with VITA VM 9 were compared with the average results of metal ceramic studies (various VMK generations in combination with various metal alloys) of the past years.

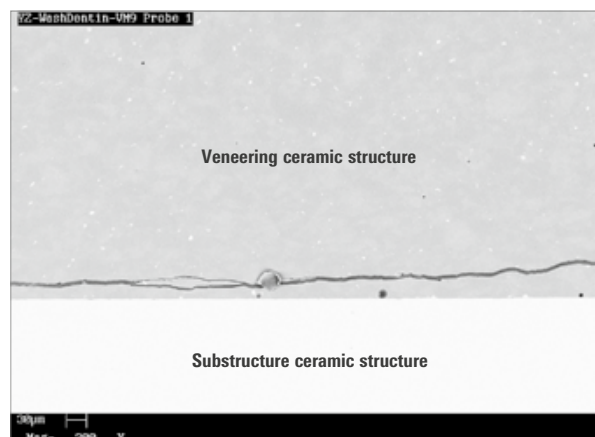
**Figures 25 :** VITA YZ T veneered with VITA VM 9, crack path in the veneer, magnification 300x

The bond of VITA YZ T to VITA VM 9 is regarded as excellent in the test series, since crack formation did not occur at all in the bonding area, but rather the cracks progressed through the layer of veneering material (see SEM picture; light gray substructure and dark gray veneering structure). Consequently, no measurable (energy) value of the actual bond can be determined.

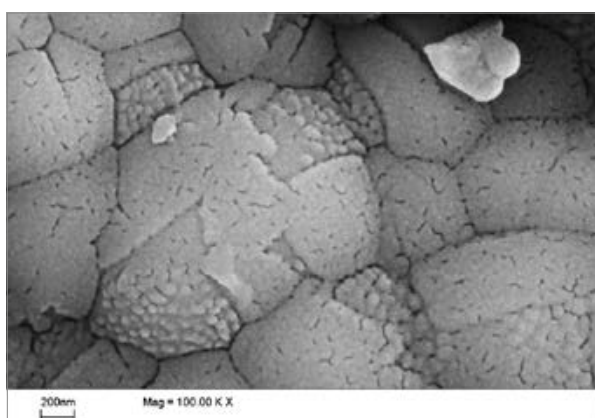
Figure 26: VITA YZ T structure after veneering, magnification 100,000x
